The Hinsdale Challenge

April 10 or 11, 1989

| HINSDALE: RETROSPECTIVE INVESTIGATION | MICHAEL J. FRIDUSS VICE PRESIDENT-OPERATIONS MICHIGAN BELL | TAB 4 |

**HINSDALE
RETROSPECTIVE INVESTIGATION**

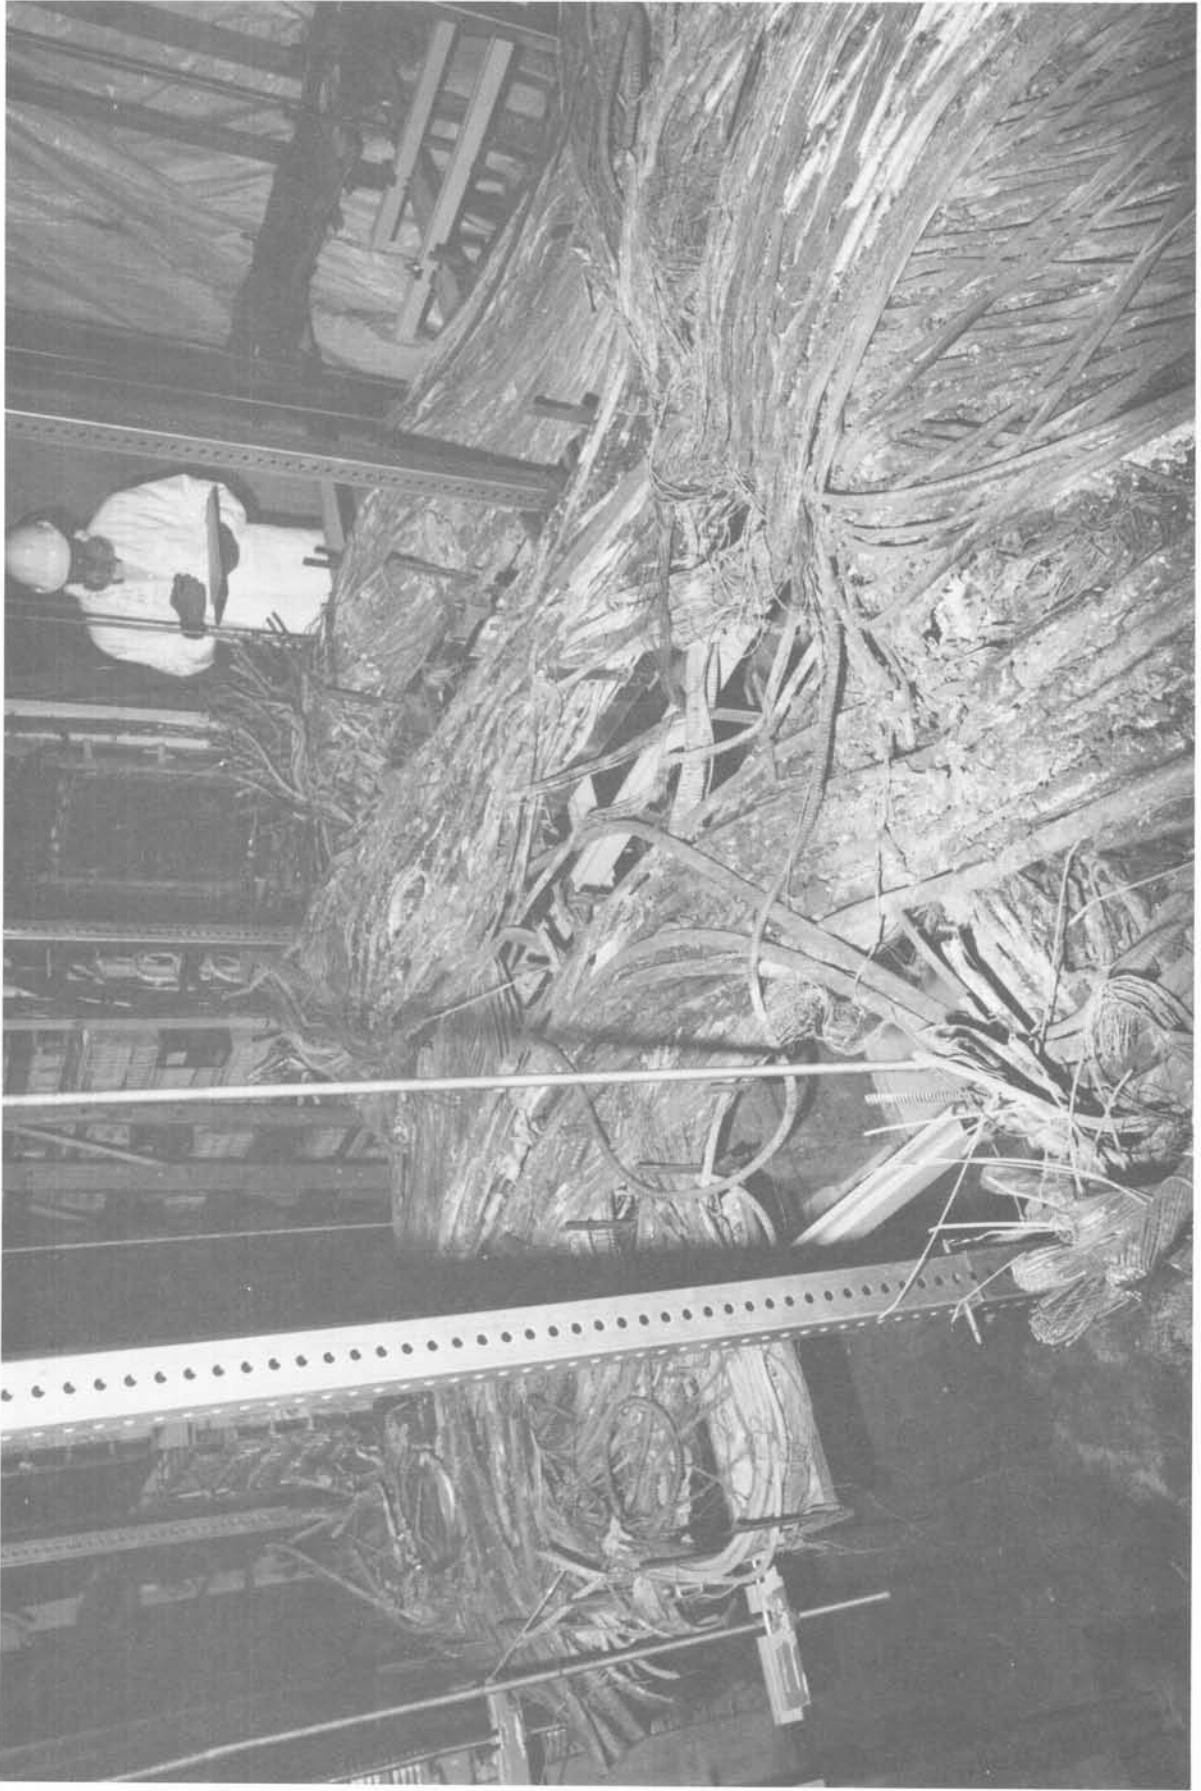
Photograph 3-3.
Section 1, after being lowered.

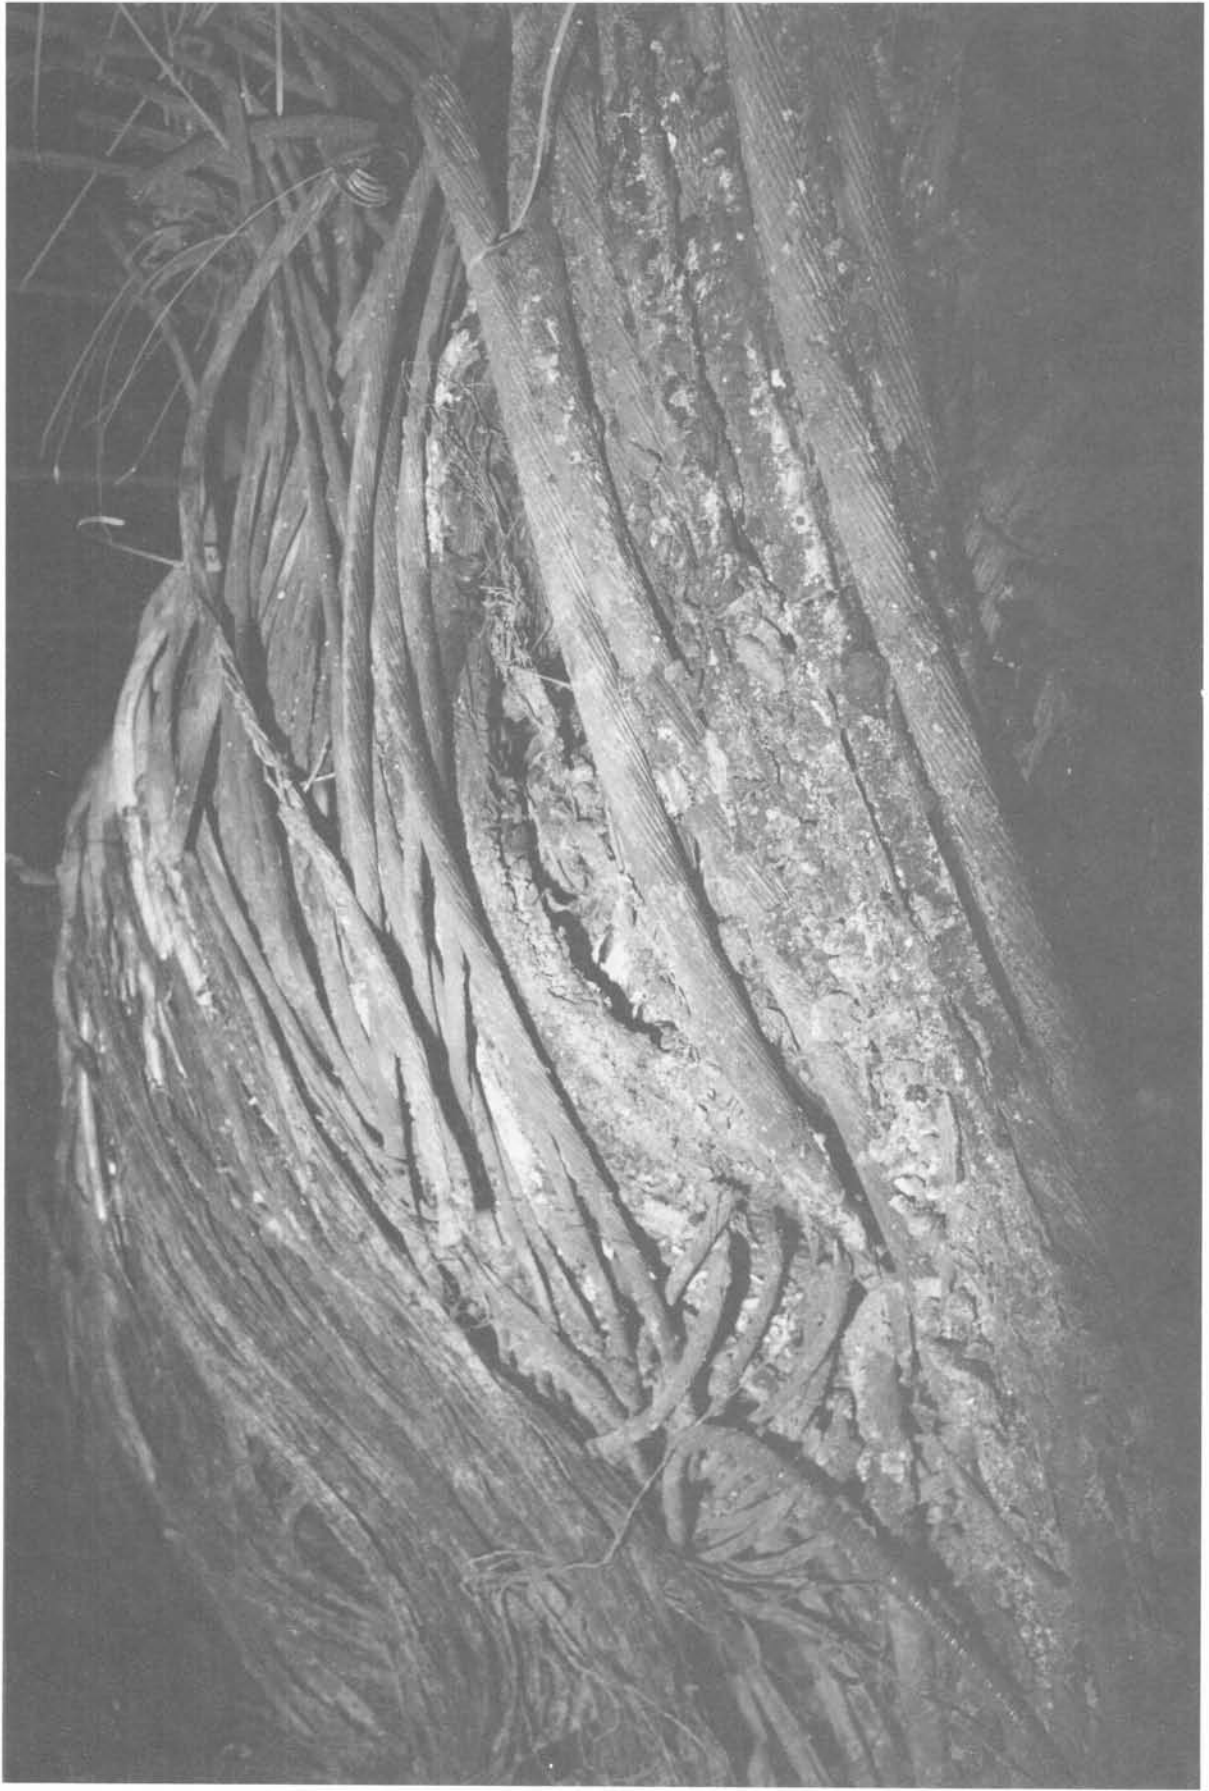
Photograph 3.9.
Section 1 near L cut showing "pocket burn."

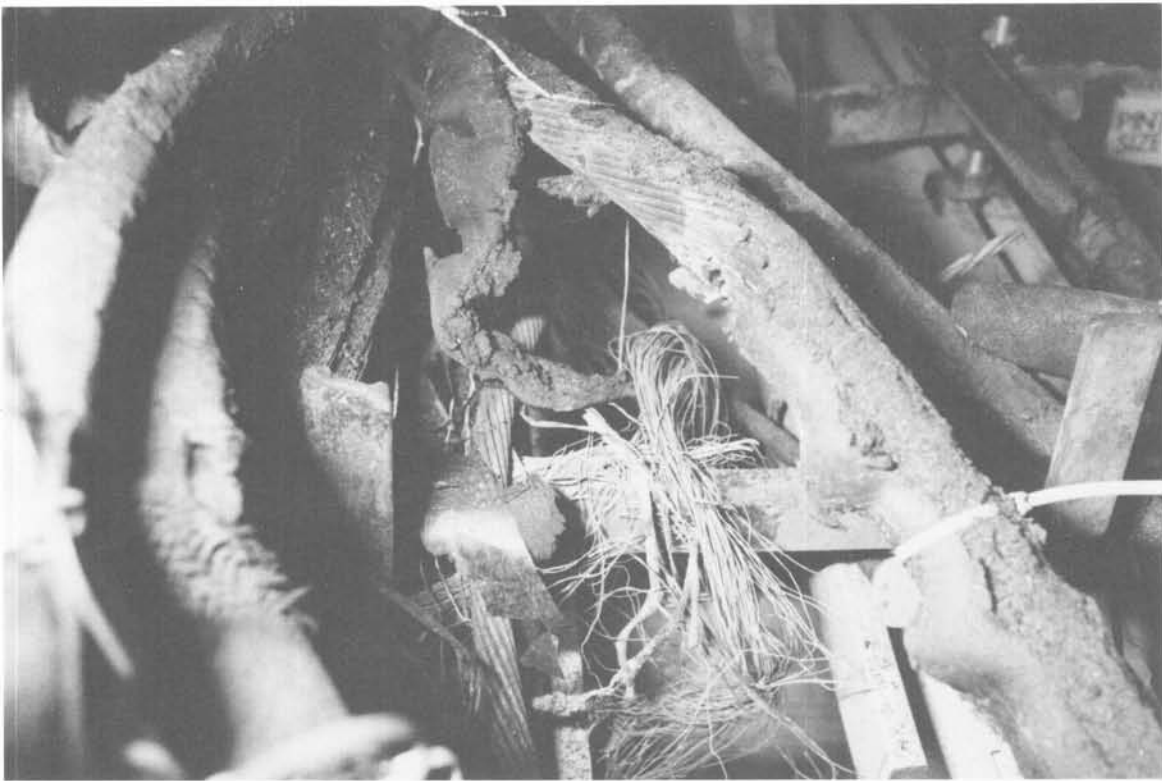
Photograph 3-45.
750 MCM power cable and stanchion; both damaged
by arcing between them, Section 1, F cut.

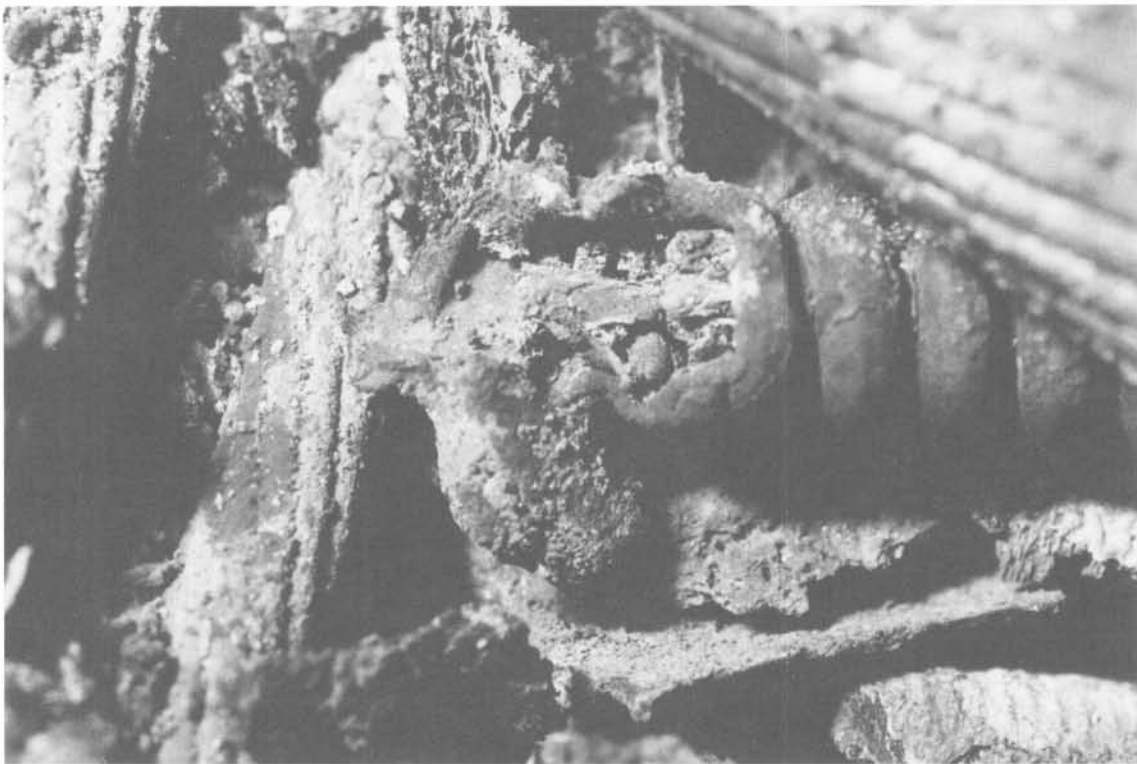
Photograph 3-15.
Armored cable welded to a 4/0 power cable
in Section 1, near L cut.

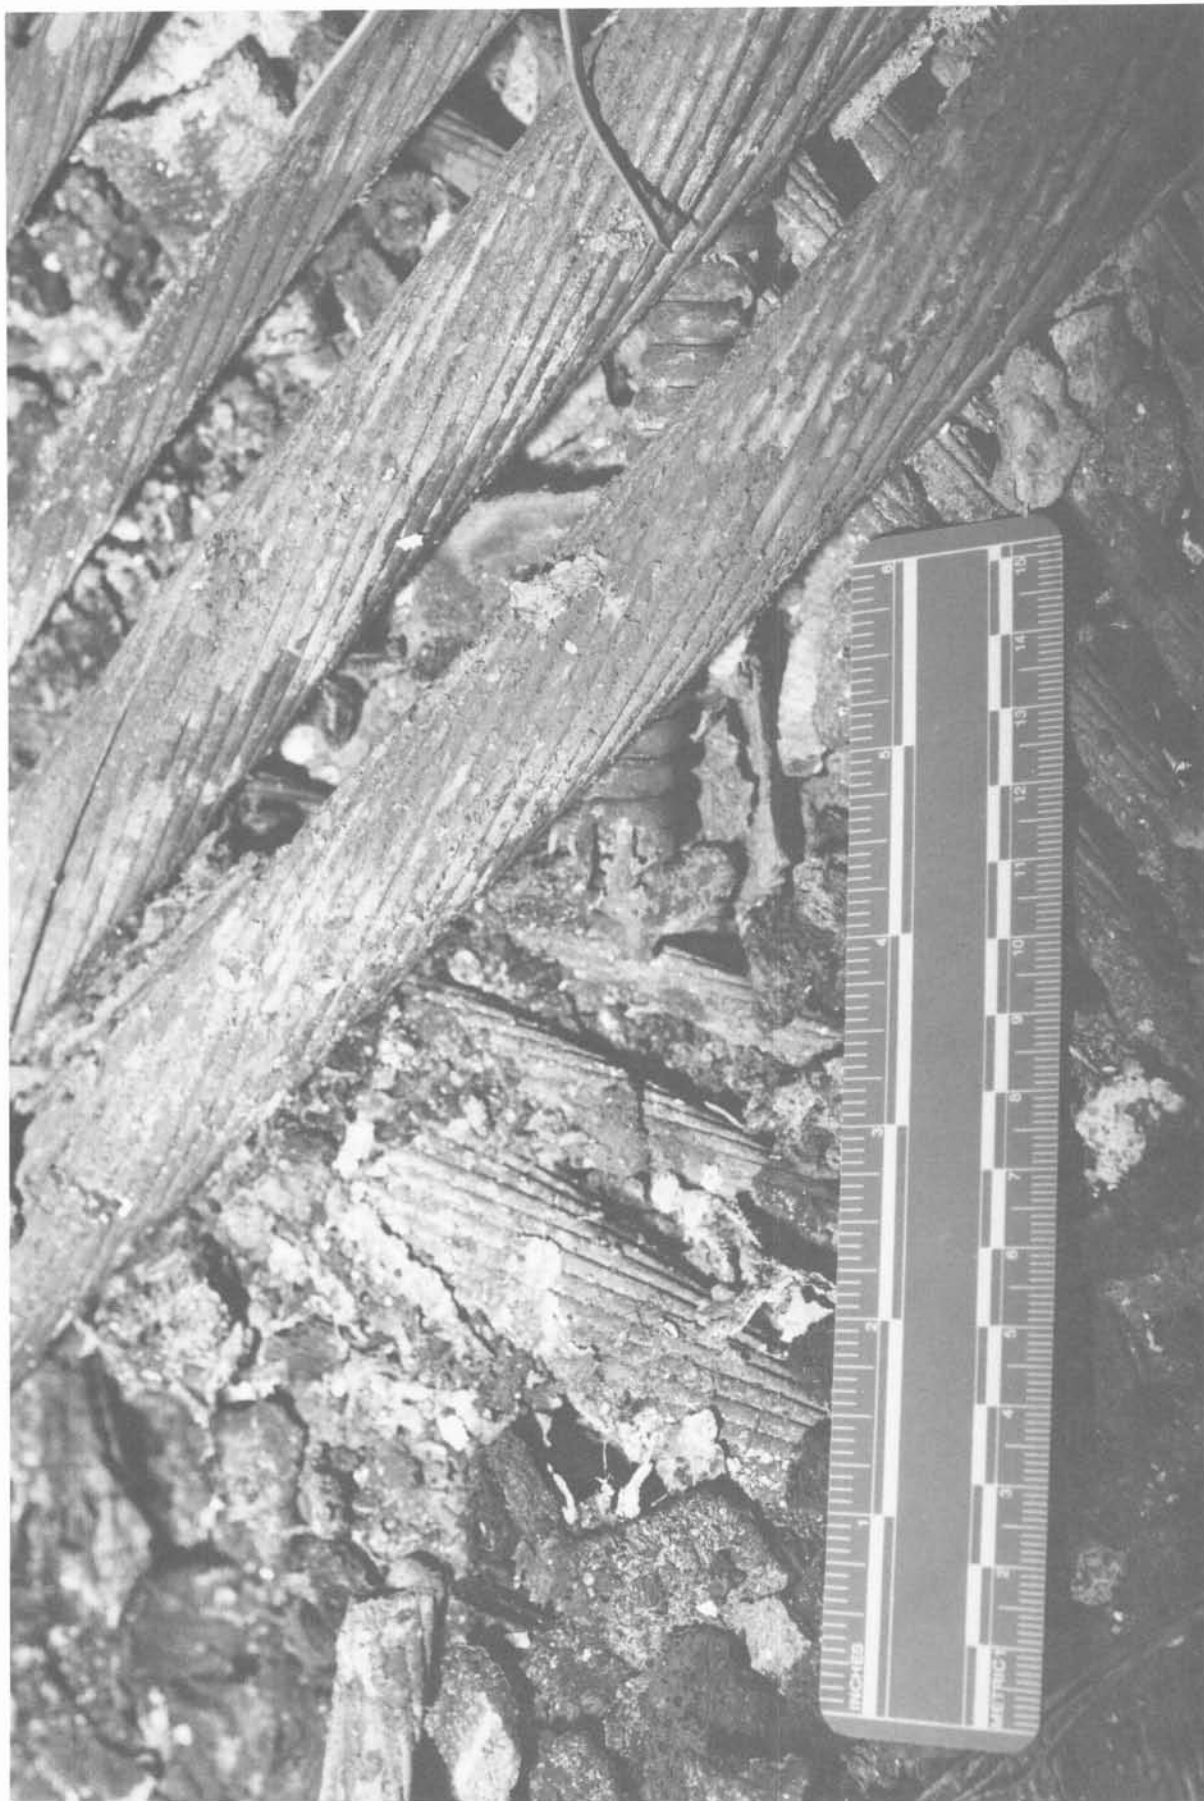
Photograph 3-17

Armored cable welded to a 4/0 AWG power cable in Section 1, near L cut.

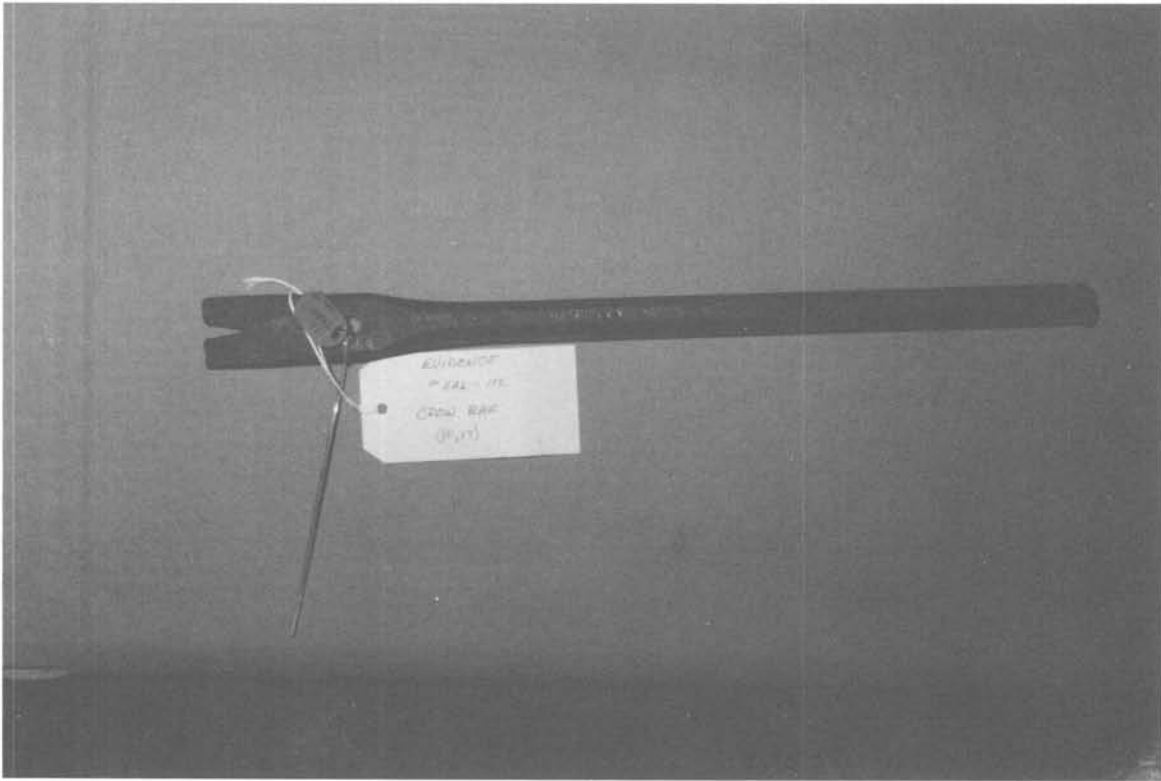
Photograph 3-54.
Prybar found among cables in cable tray in northeast corner of toll area.

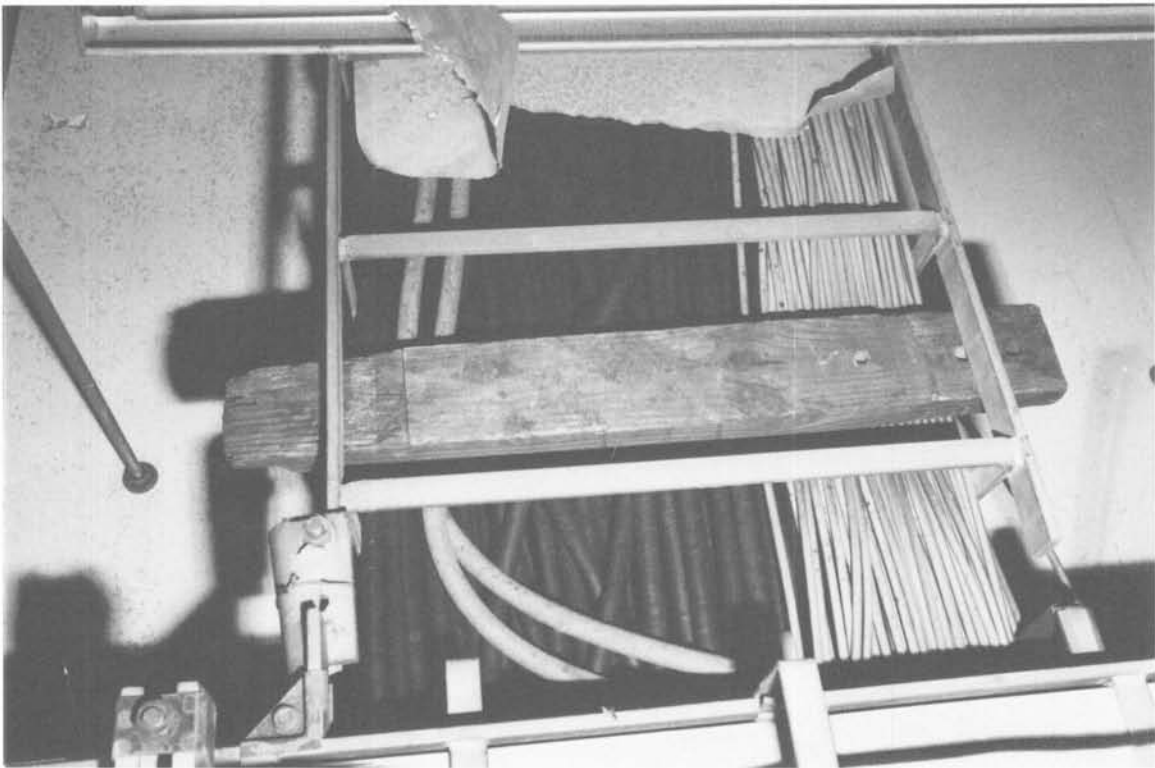
Photograph 3-57.
Exposed makeshift wedge found in cable tray in northeast corner of first floor.

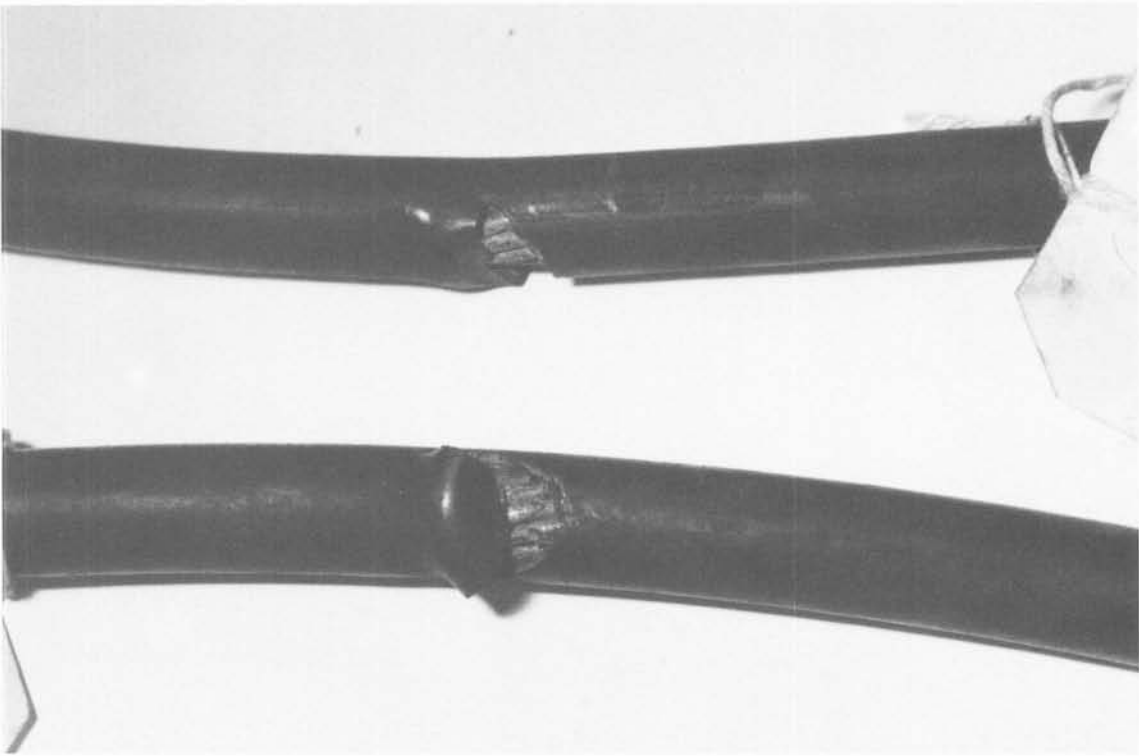
Photograph 3-59.
Torn insulation on extracted power cables.

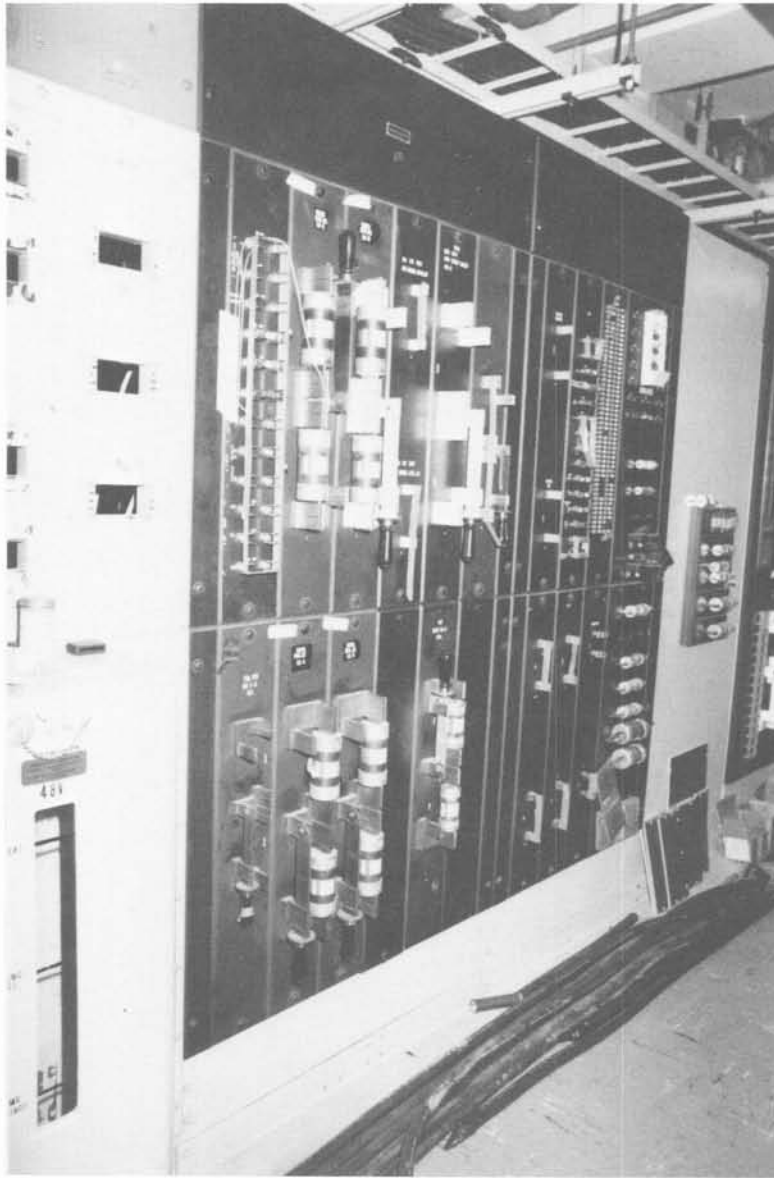
Photograph 3-39.
302 power system 600-ampere main fuses.

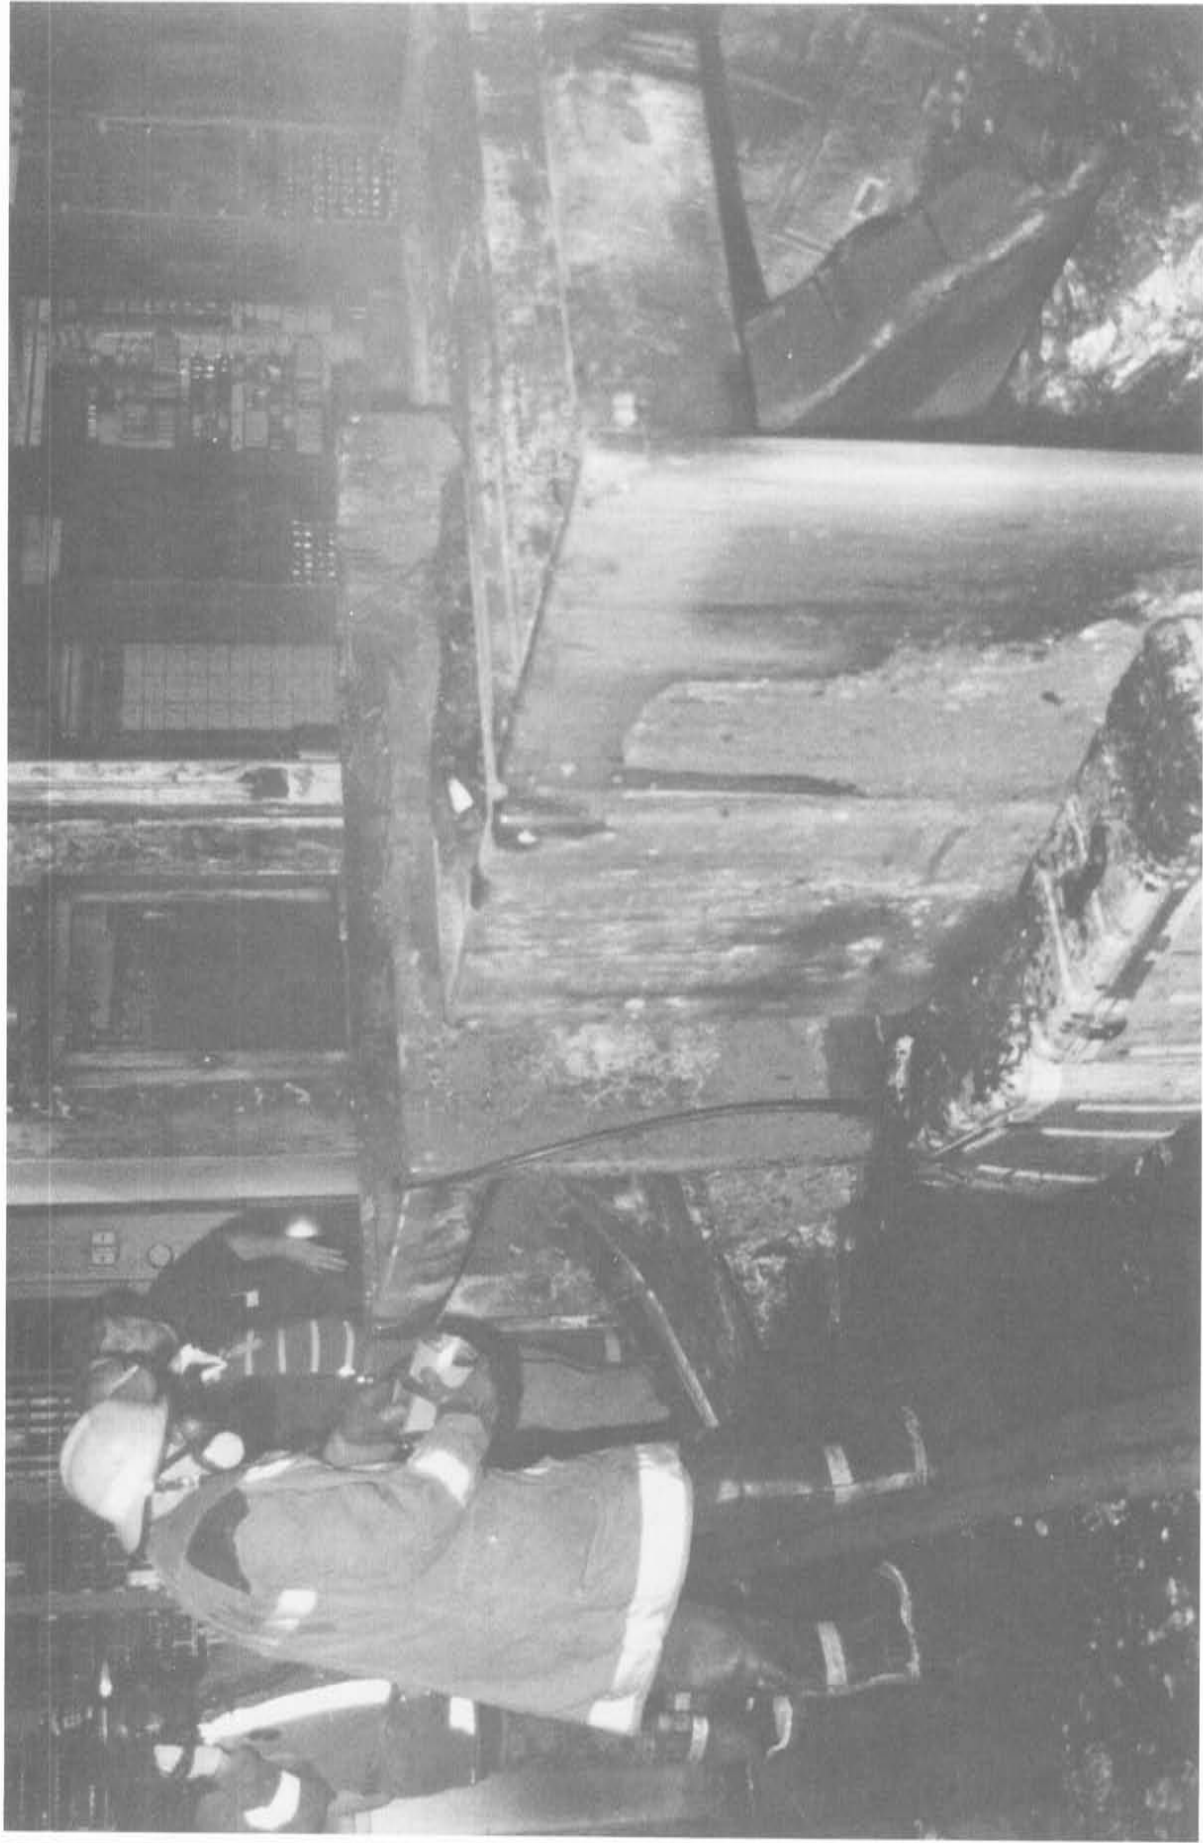
Photograph 3.
Firemen examining card bins after the fire was extinguished.
(Photo courtesy of the Hinsdale Fire Department.)

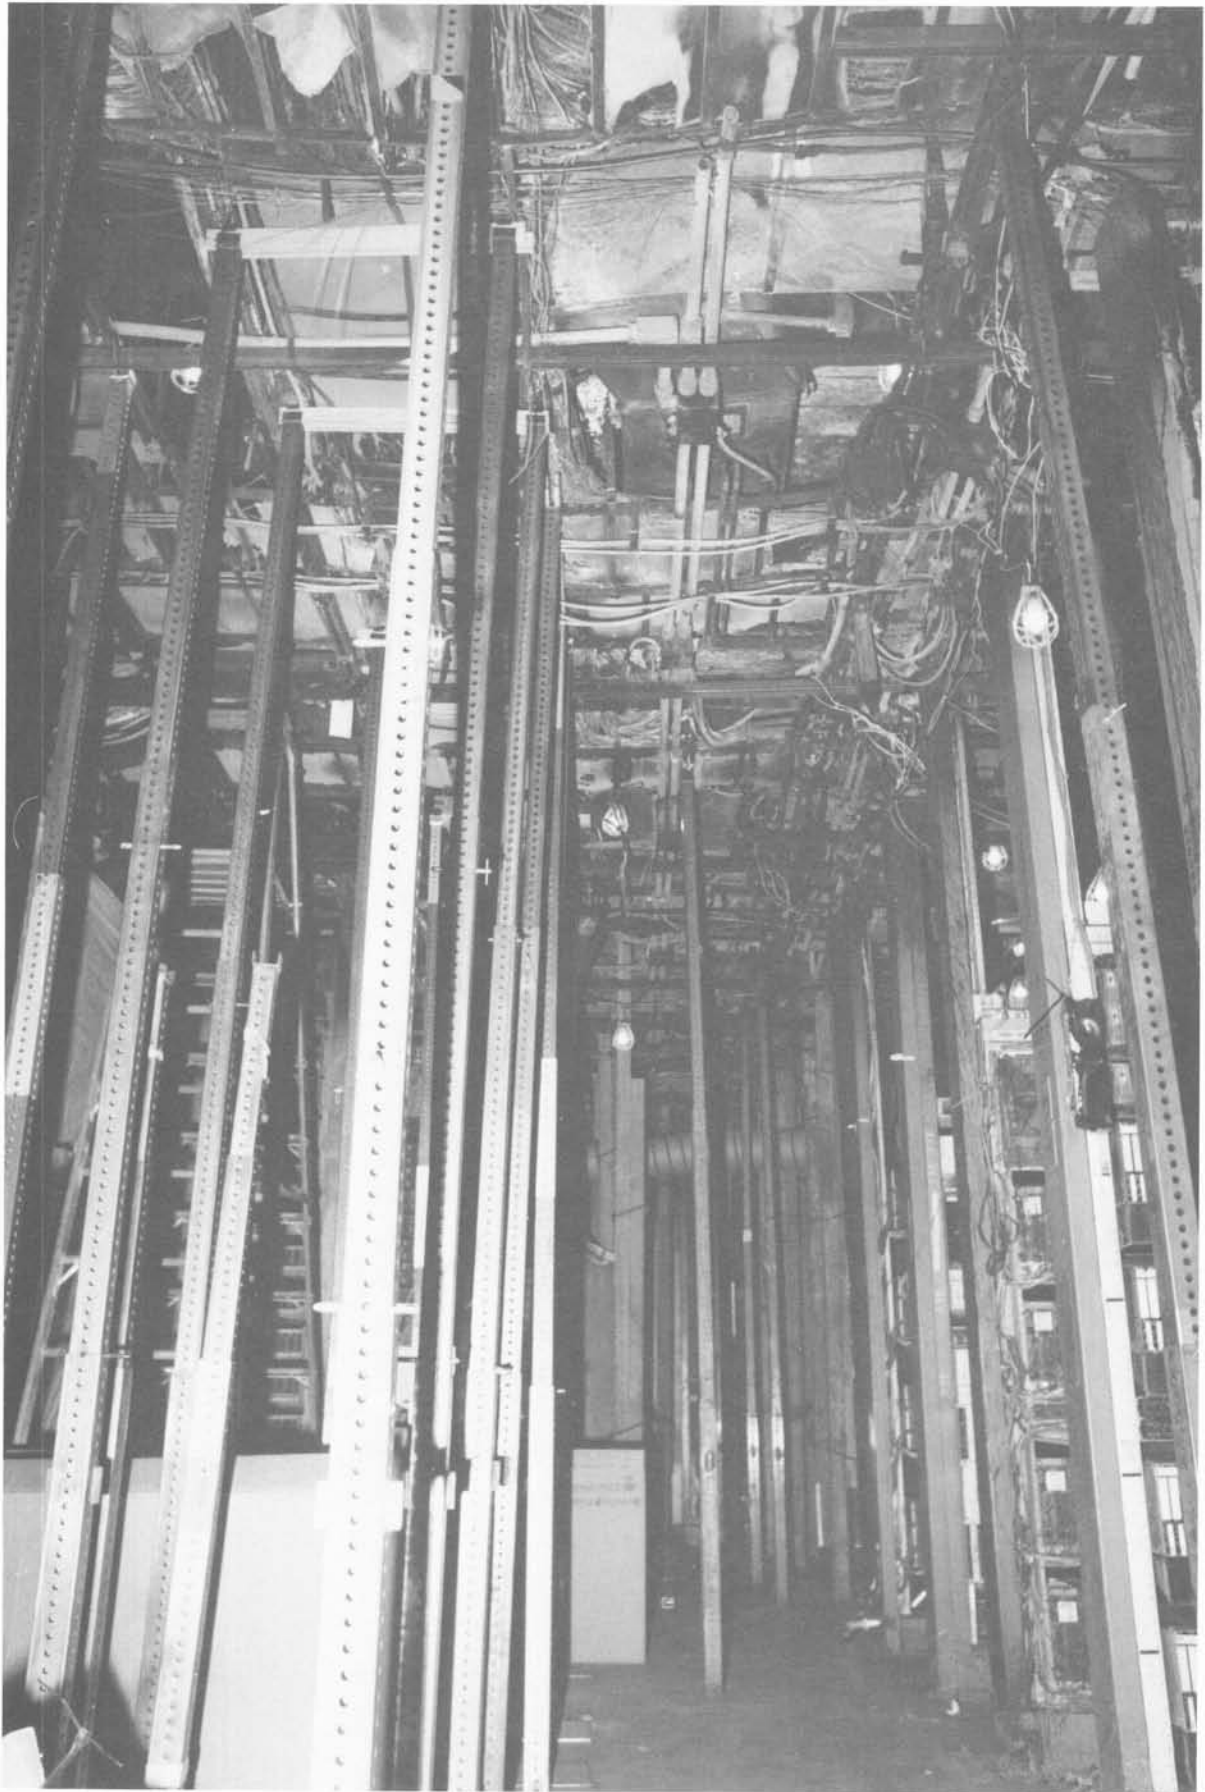
Photograph 2-14.
Cable trays, Sections 1 and 2, looking north.

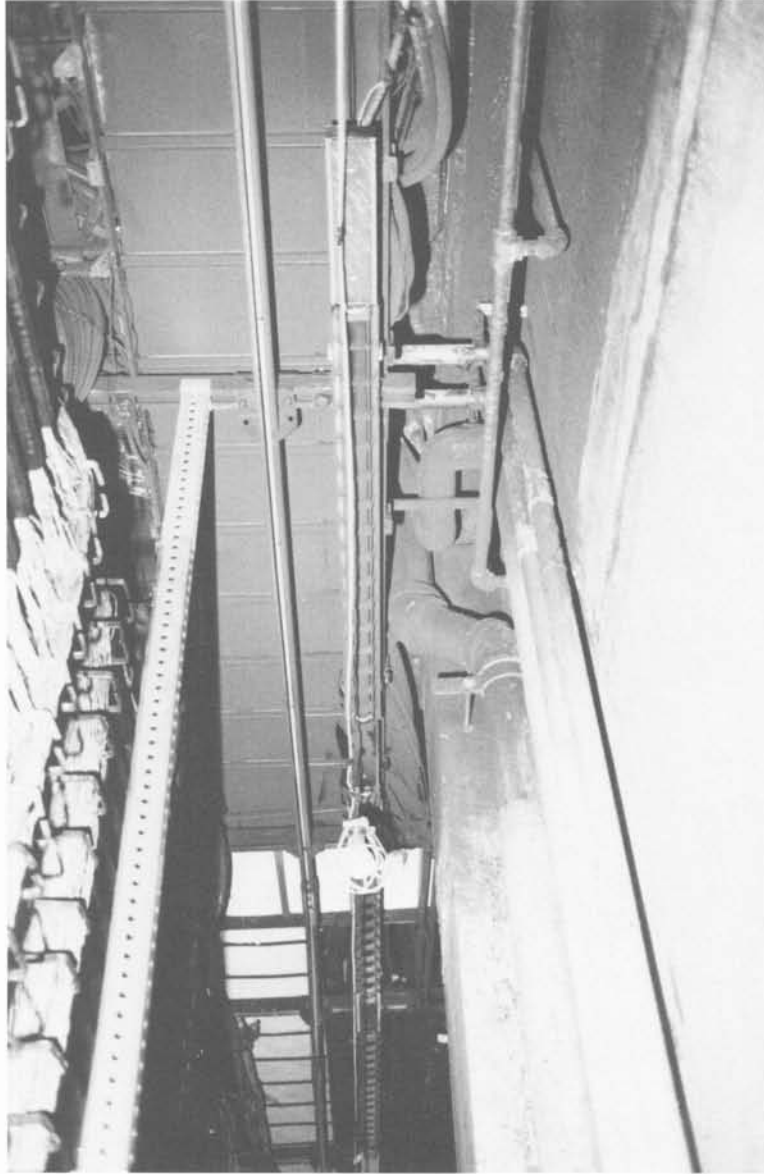
Photograph 2-18.
Smoke damage on bottom of cable tray
and upper walls.

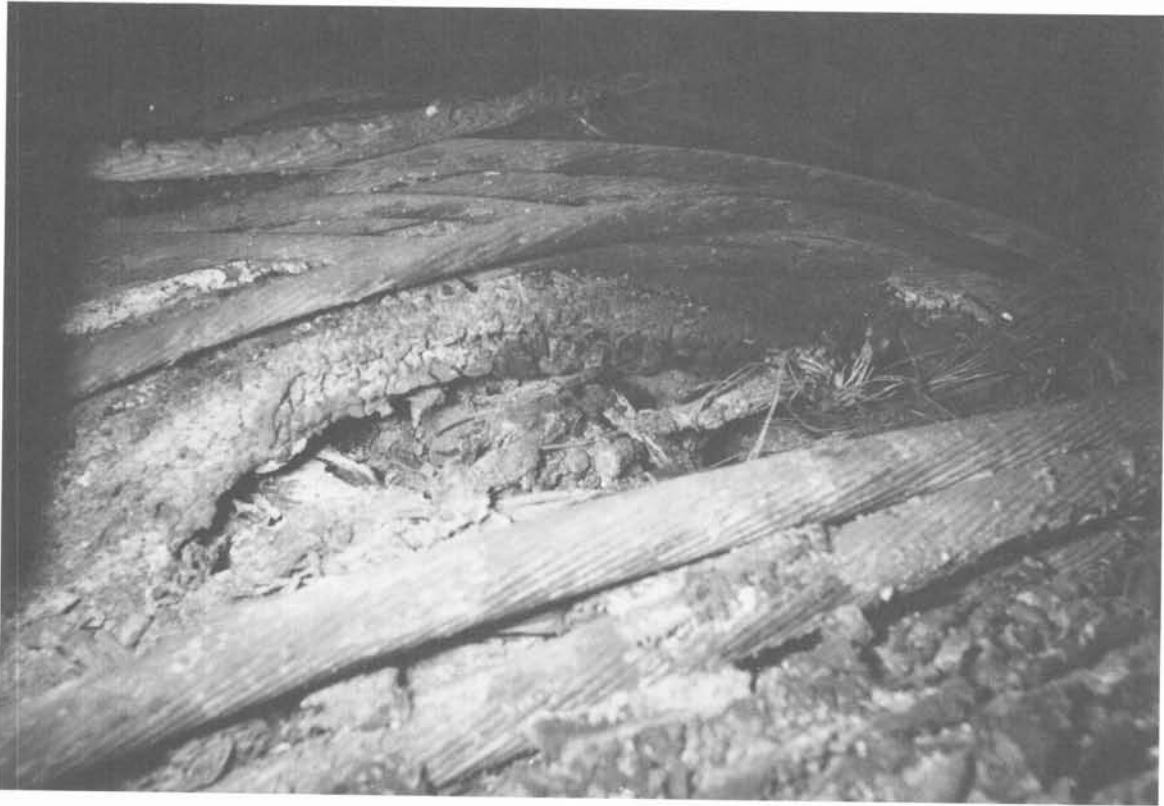
Photograph 3-10.
Close-up of "pocket burn," Section 1.

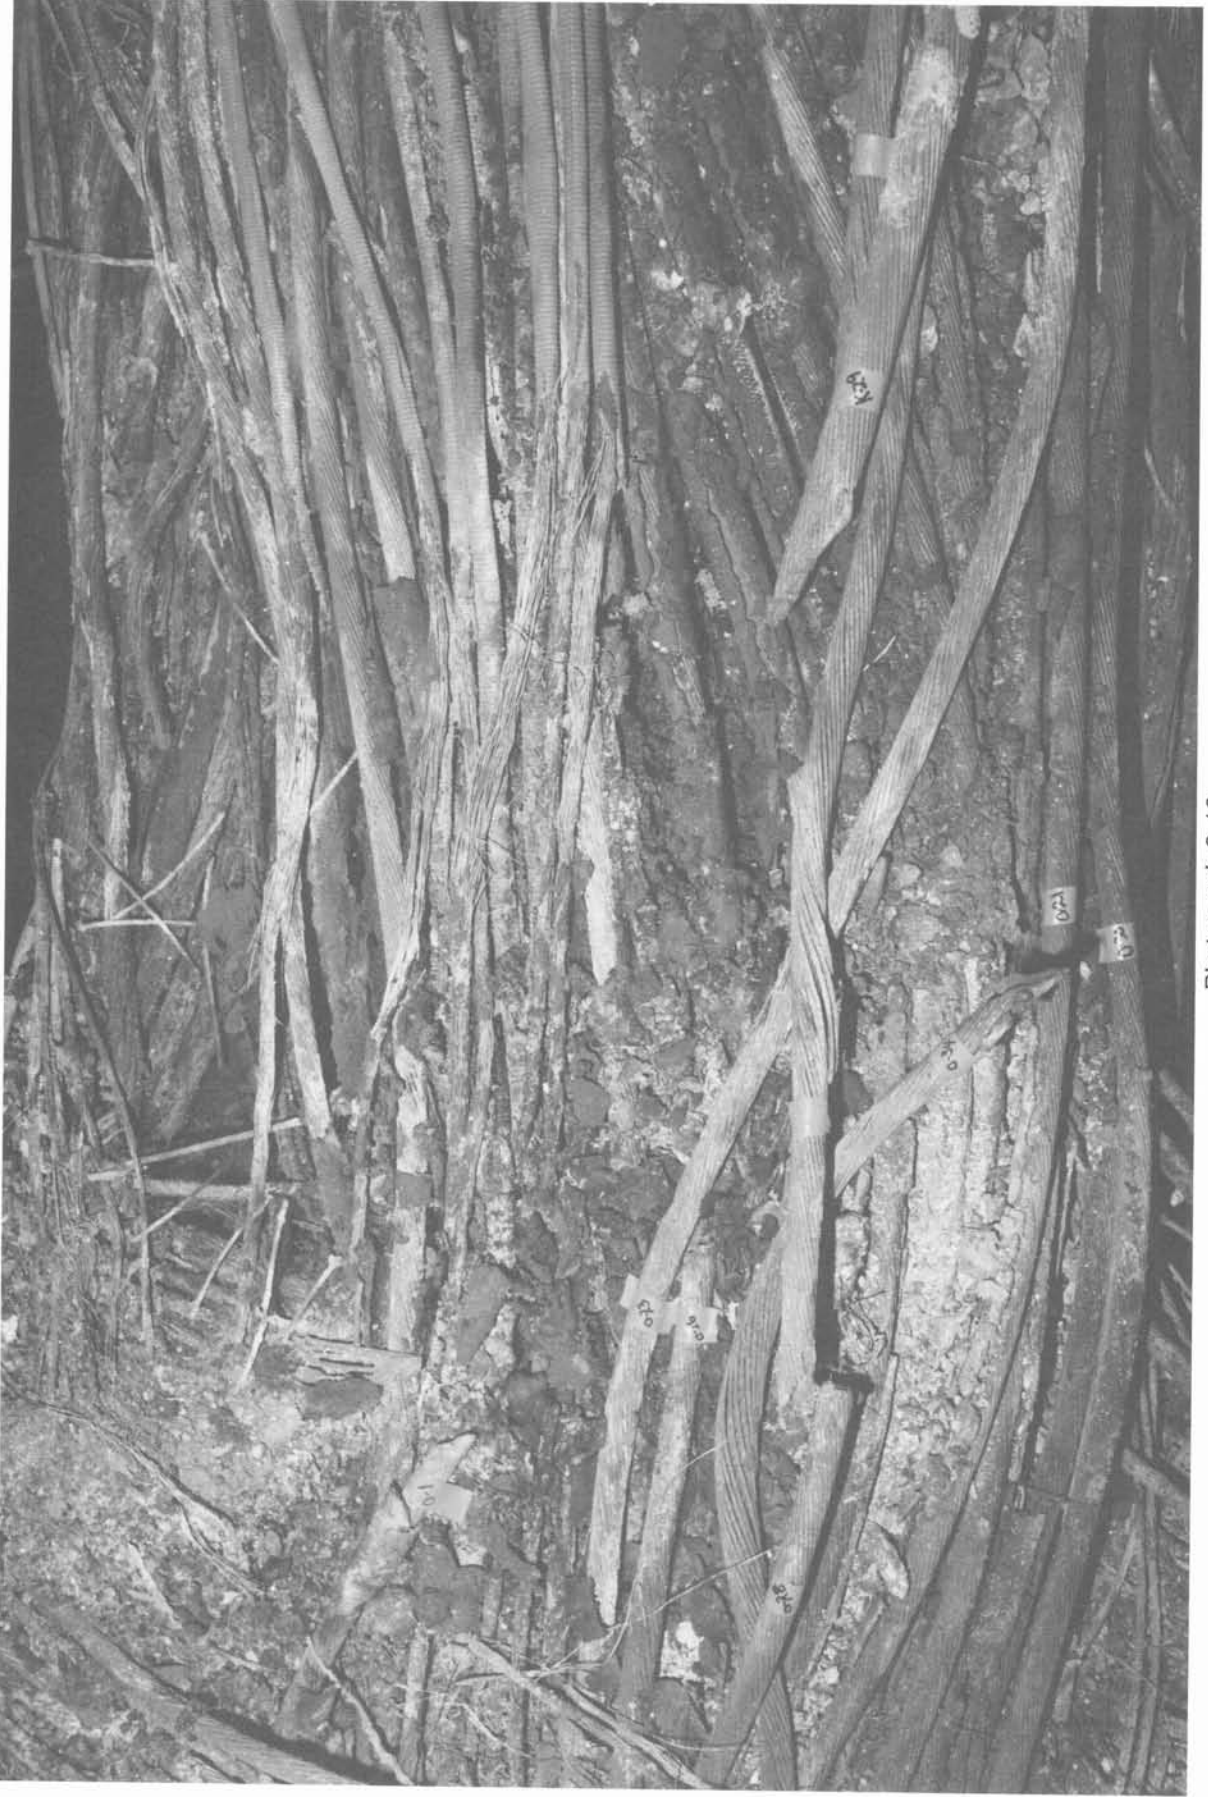
Photograph 3-12.
Large power cables arced-in-two in Section 2, near O cut.

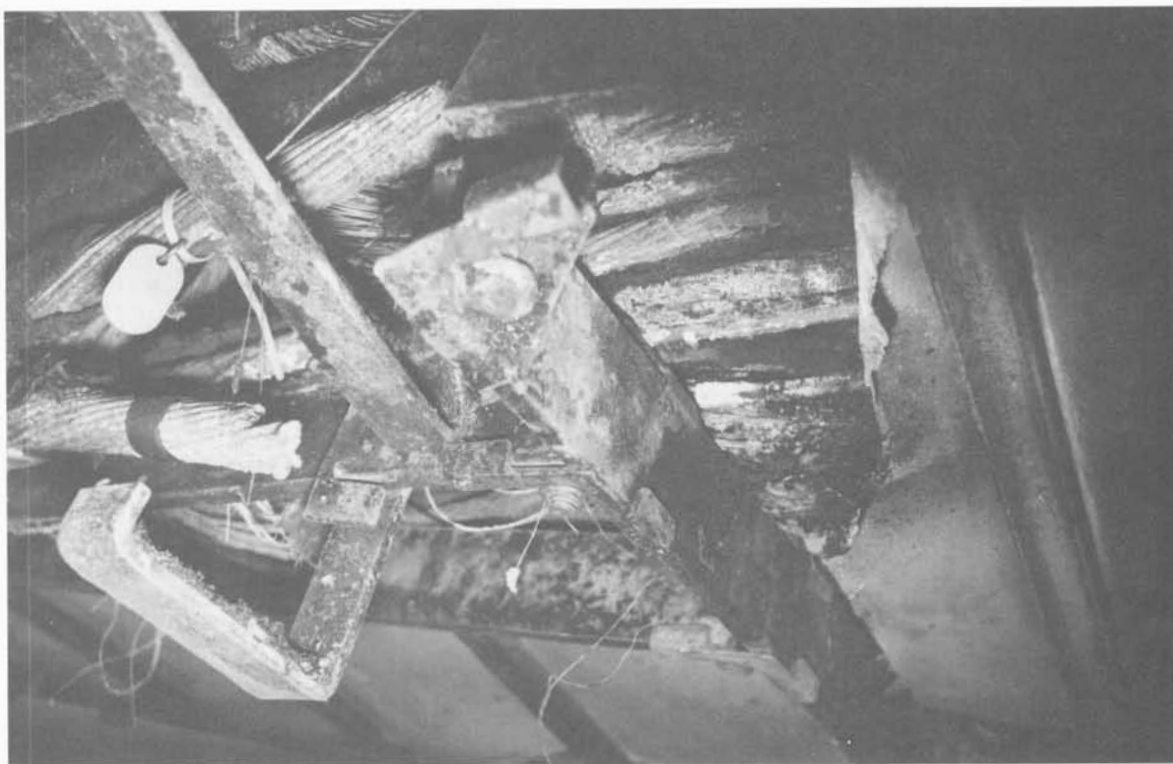
Photograph 3-16.
Damage caused by arcing from cable to tray frame.

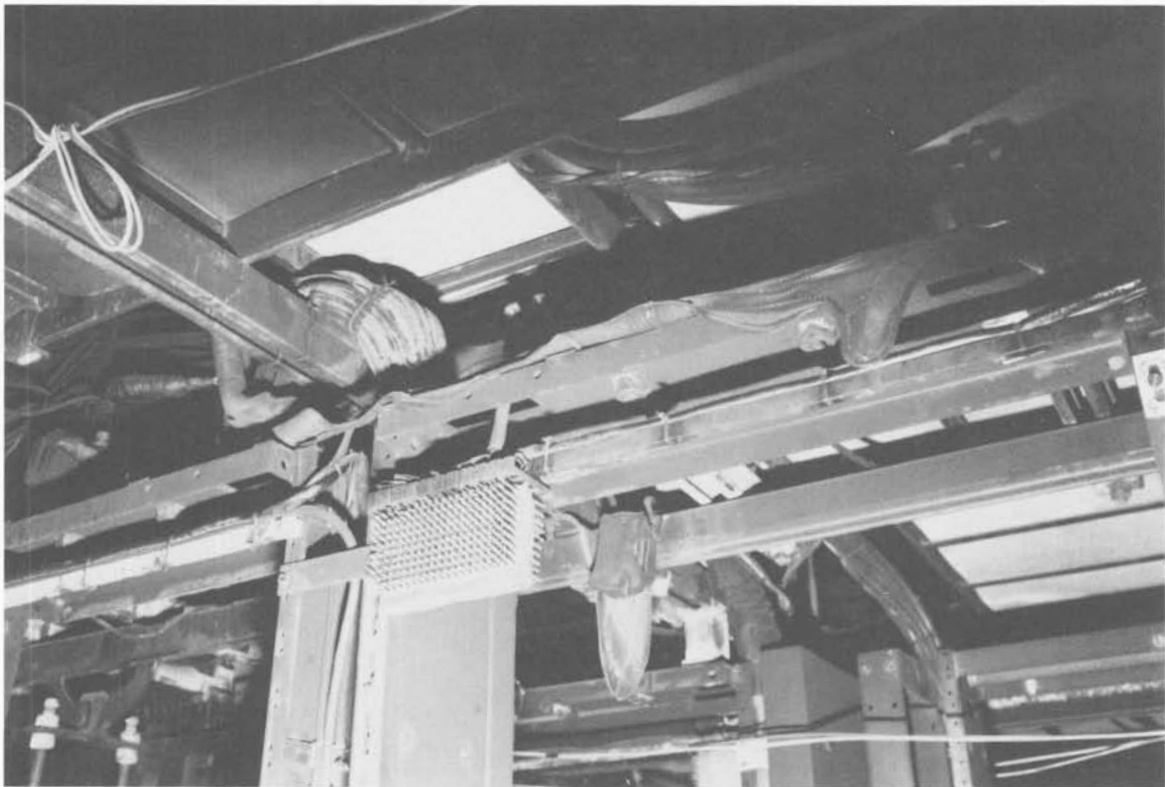
Photograph 3-18.
Melting of plastic cable covers and connectors at equipment
bay frames below cable trays outside fire area.

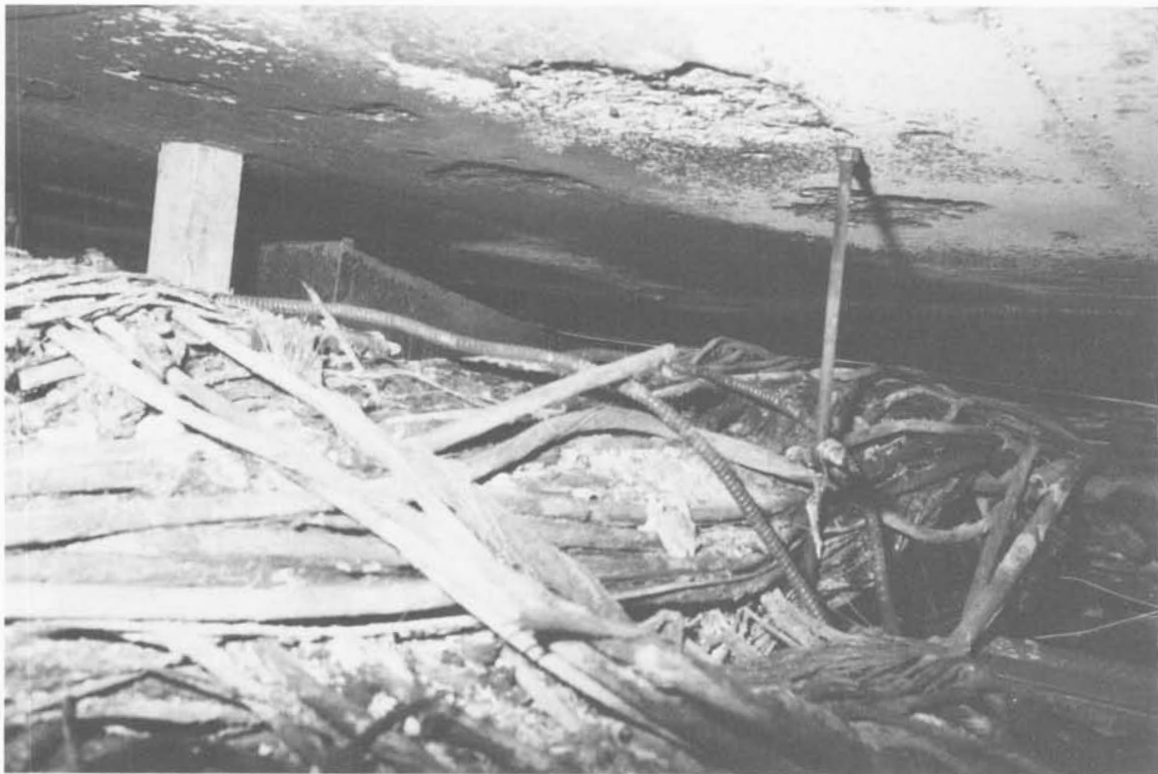
Photograph 3-20.
Spalling of concrete above arced cables in cable trays, Section 2.
