The Hinsdale Challenge

April 10 or 11, 1989

| HINSDALE: RETROSPECTIVE INVESTIGATION | MICHAEL J. FRIDUSS VICE PRESIDENT-OPERATIONS MICHIGAN BELL | TAB 4 |

**HINSDALE
RETROSPECTIVE INVESTIGATION**

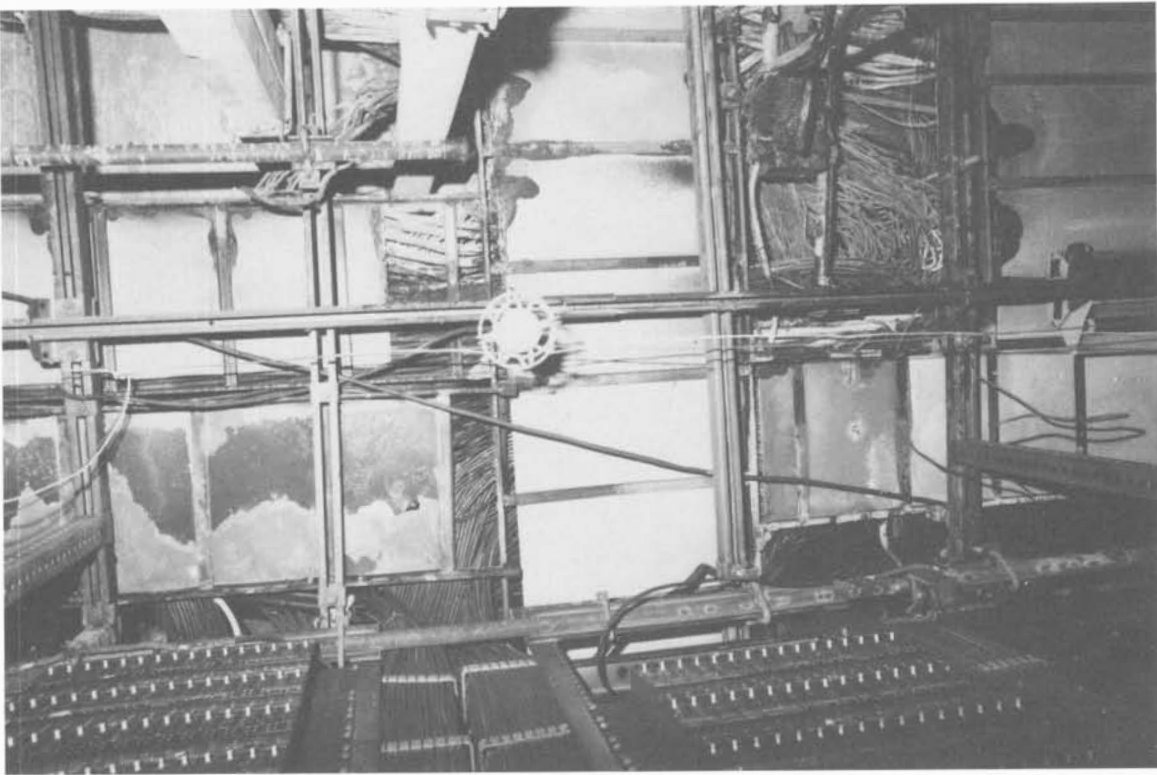
Photograph 3-21.
Burn and melt limits near north wall.

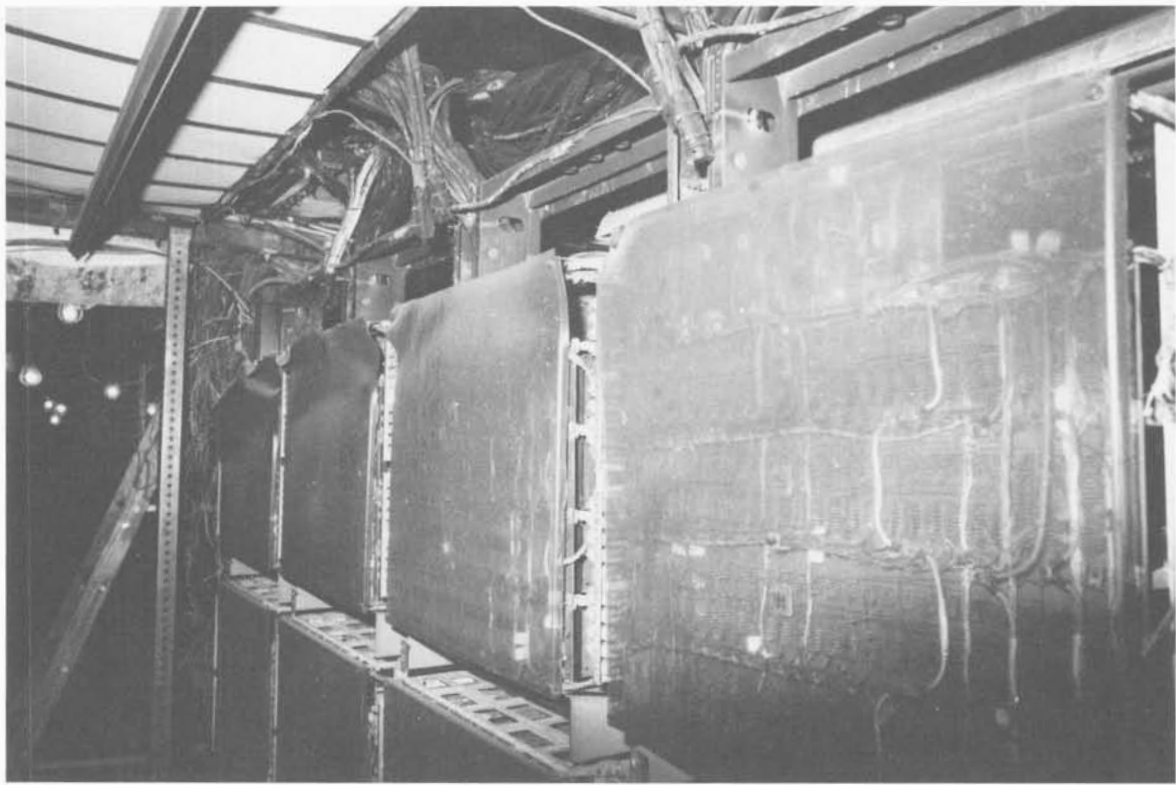
Photograph 3-23.
Soot buildup on equipment bays above B cut, Section 1.

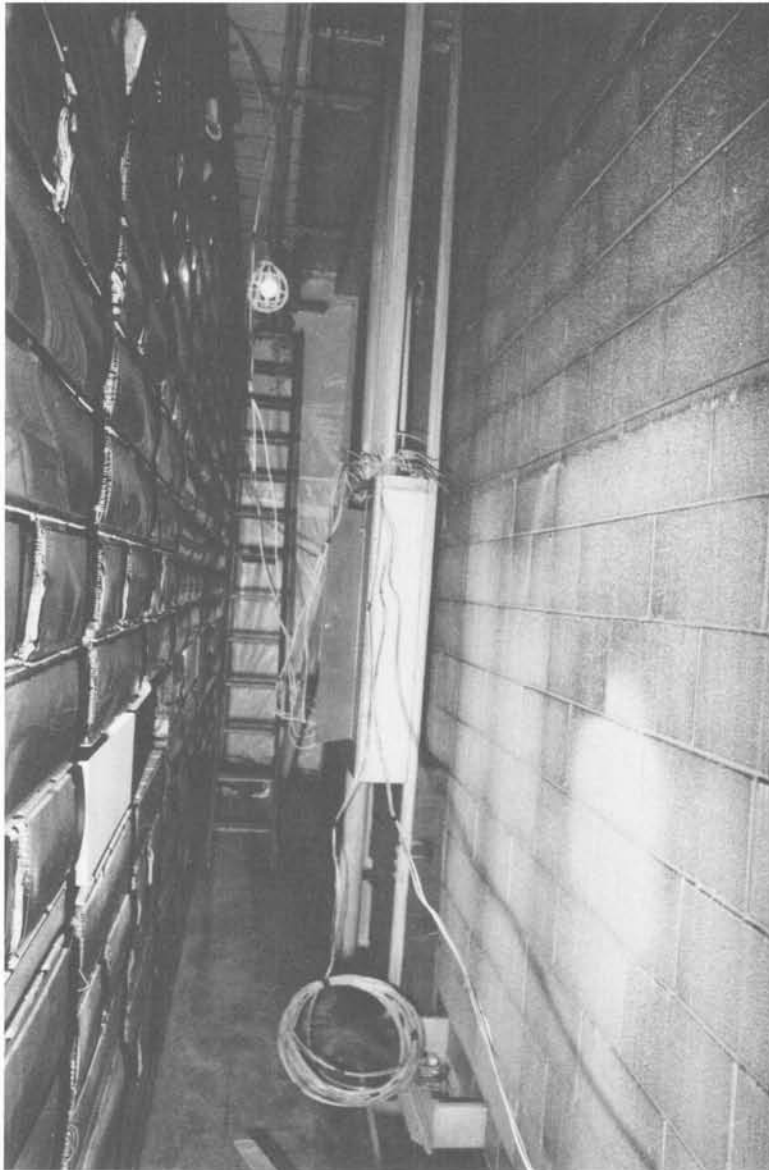
Photograph 3-25.
Smoke damage in northwest corner of toll area,
first floor. (North wall.)

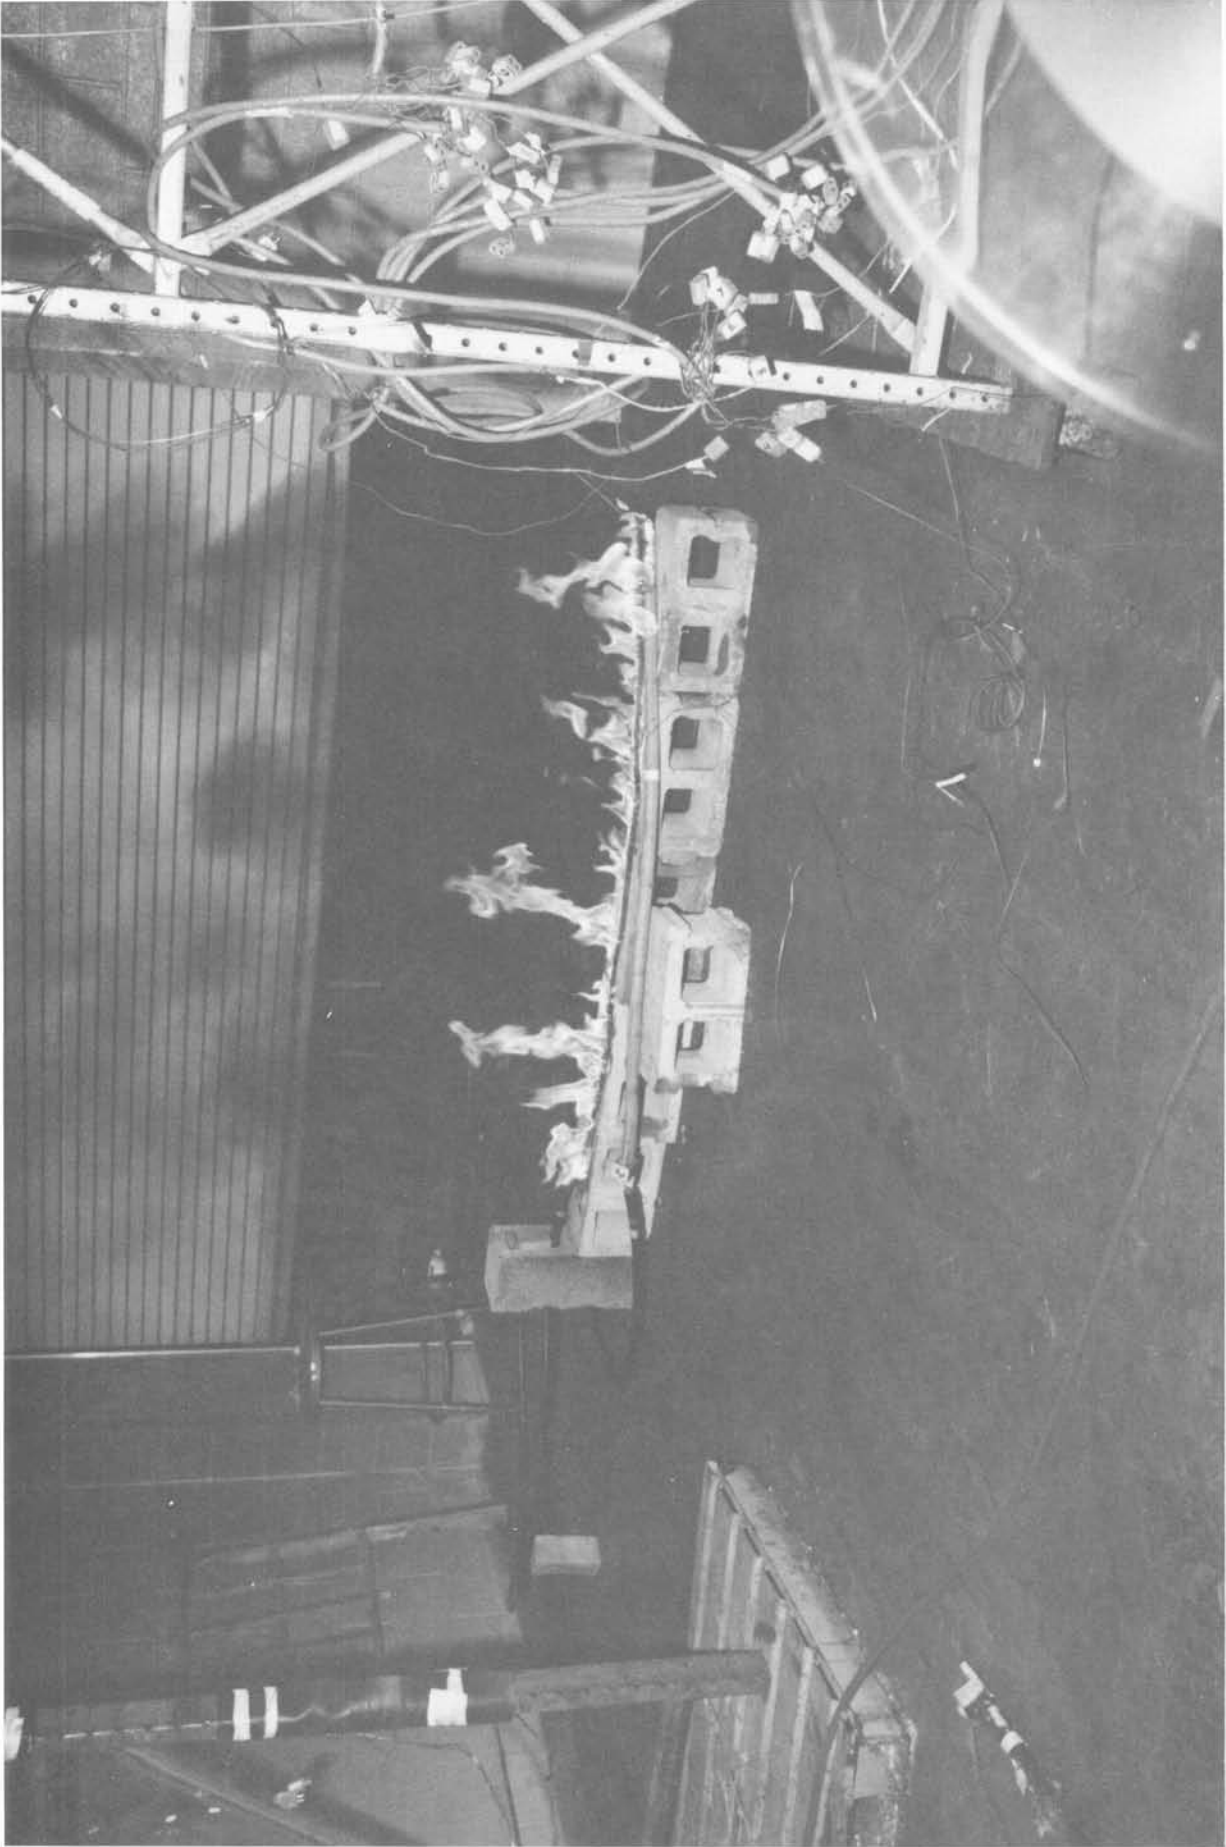
Photograph 4-2.
Test BX-4, Aluminum armor of cable burning.

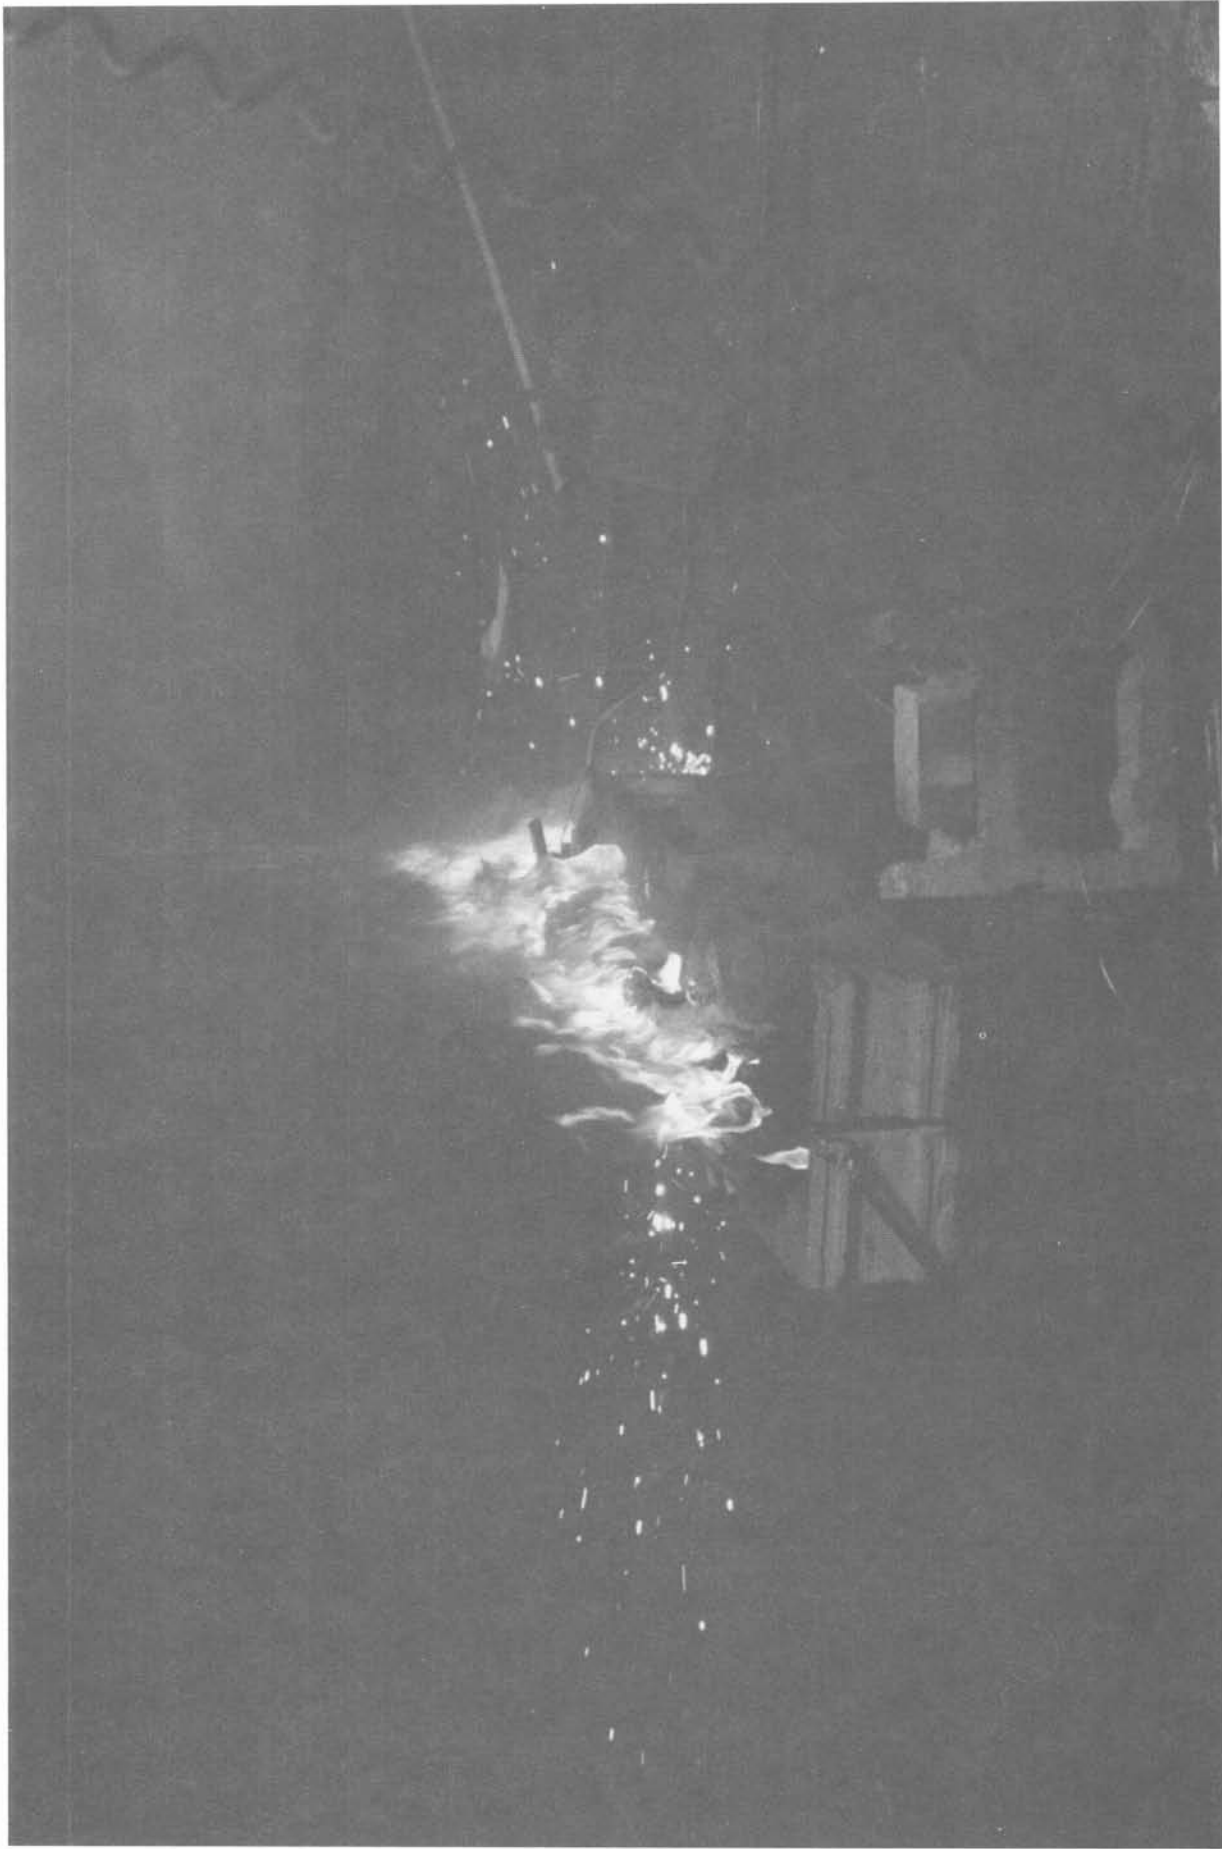
Photograph 4-6.
Test SS-9, arcing, full involvement of cable bundle.

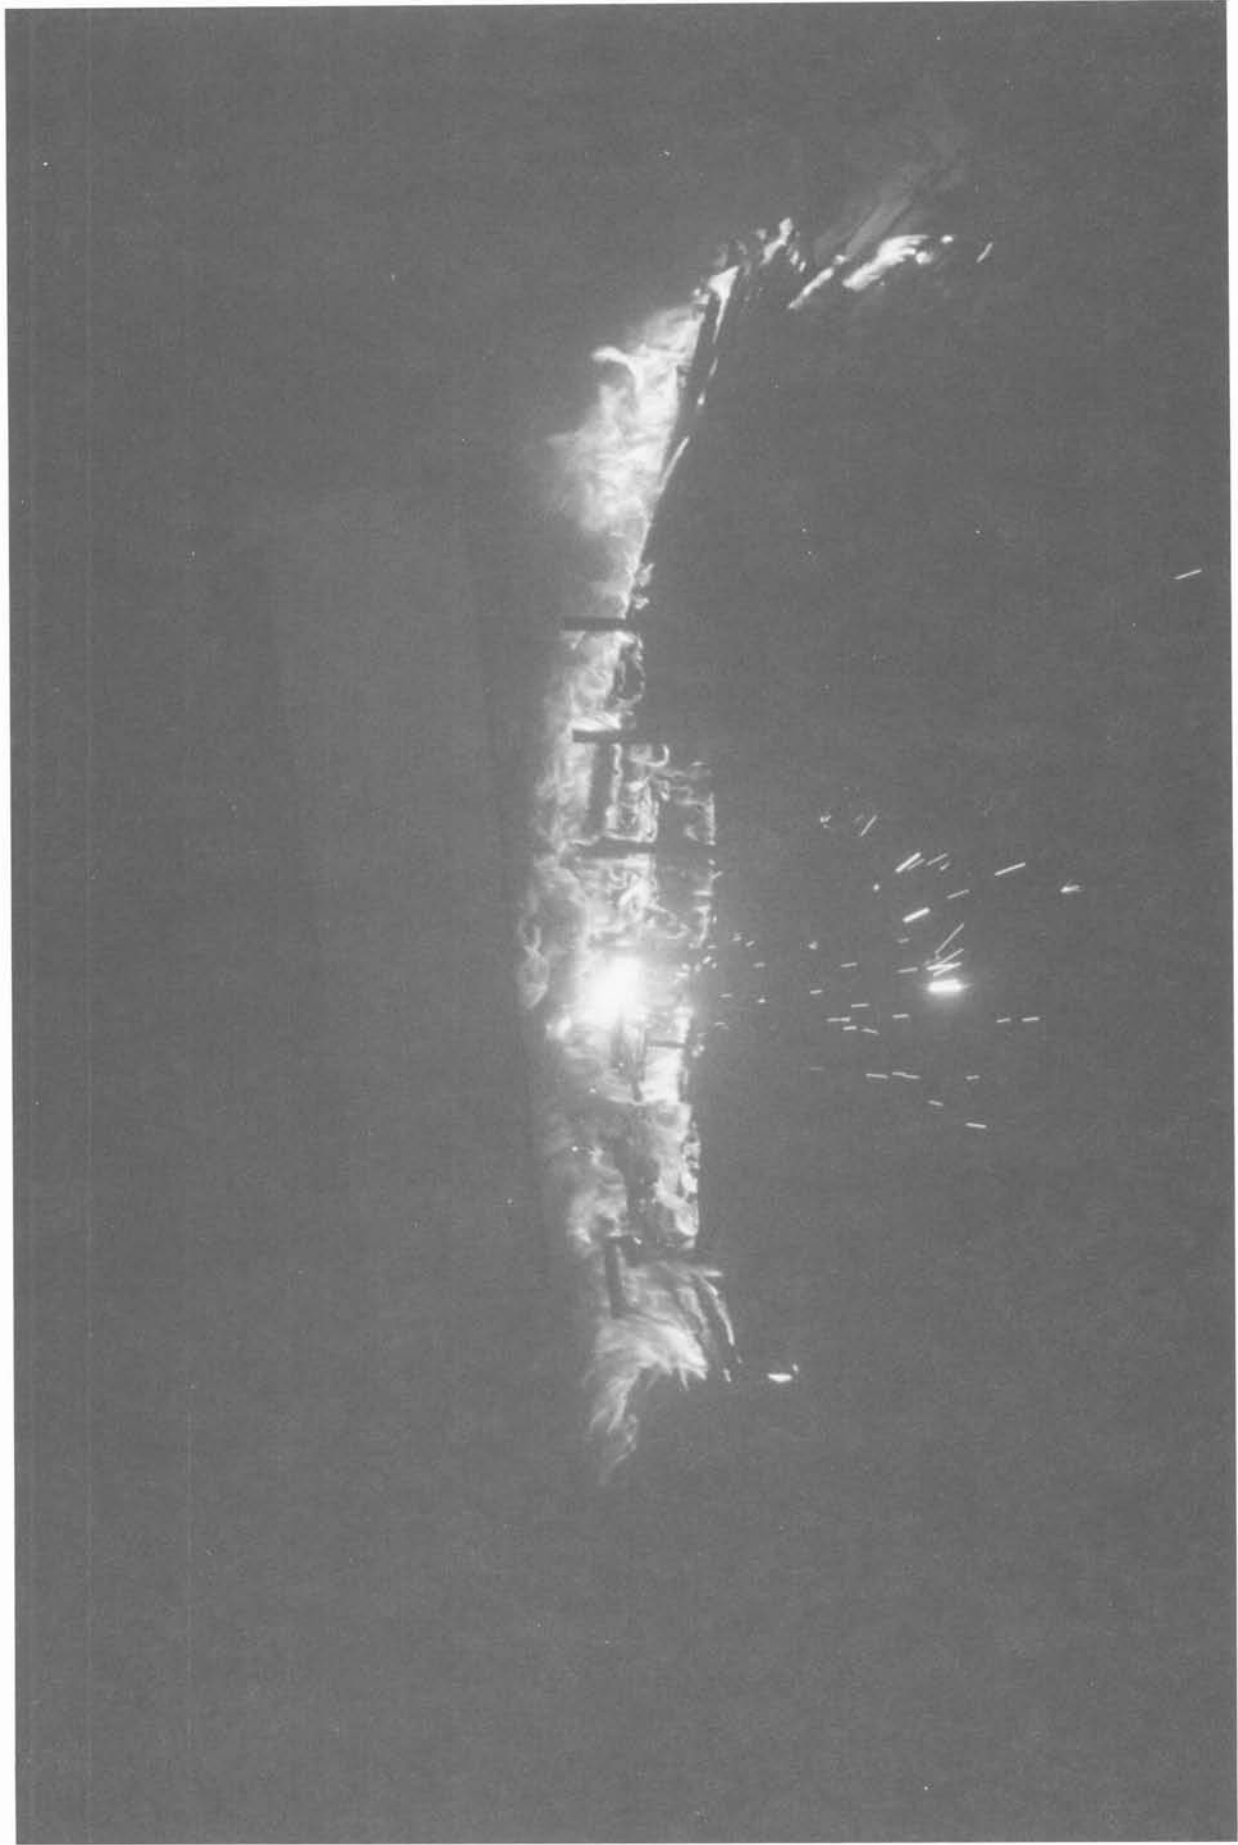
Photograph 4-20.
Fully involved cable bundle; arcing to stanchion, Test ULN-2.

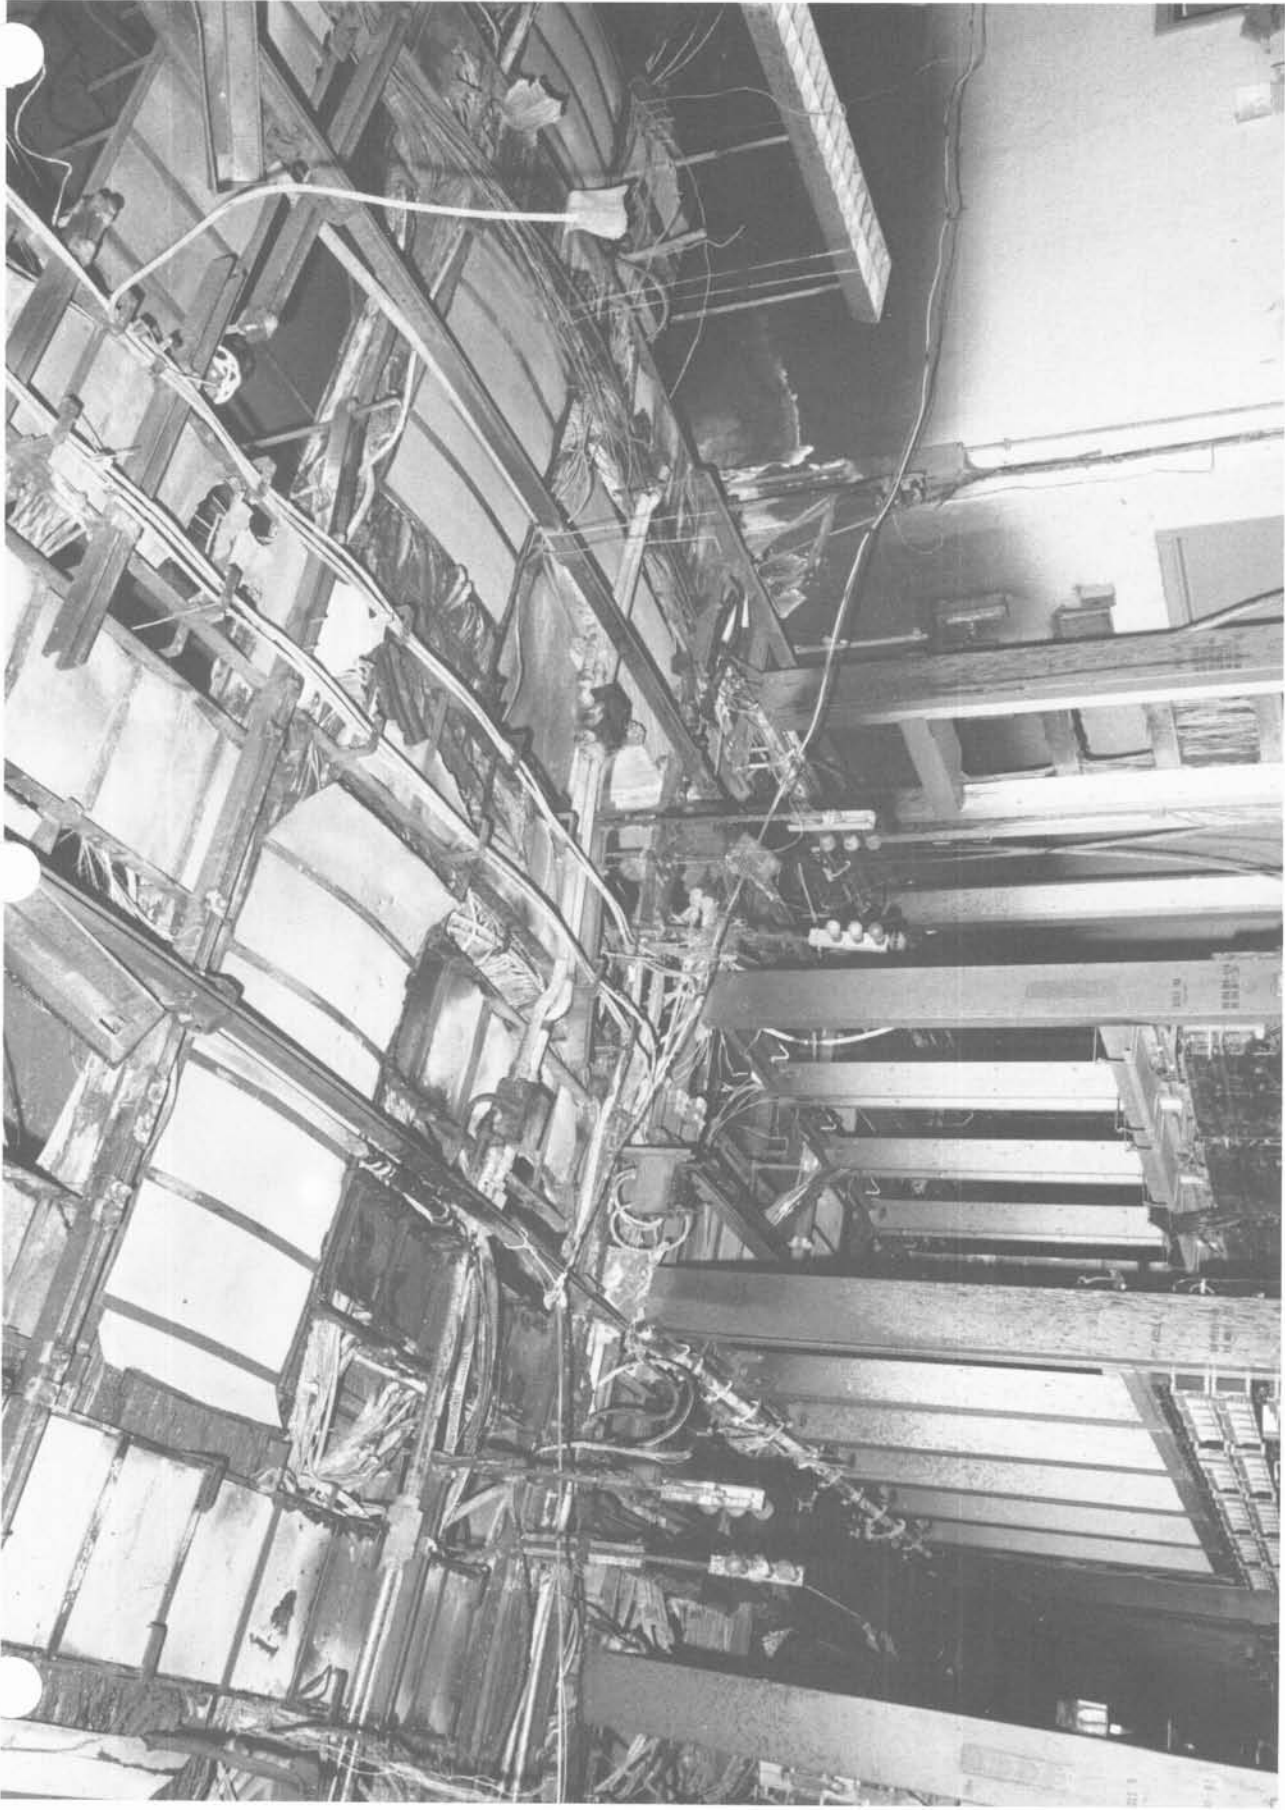
Photograph 2.
Fire damaged cable trays suspended from ceiling in the Toll Equipment Area of the first floor

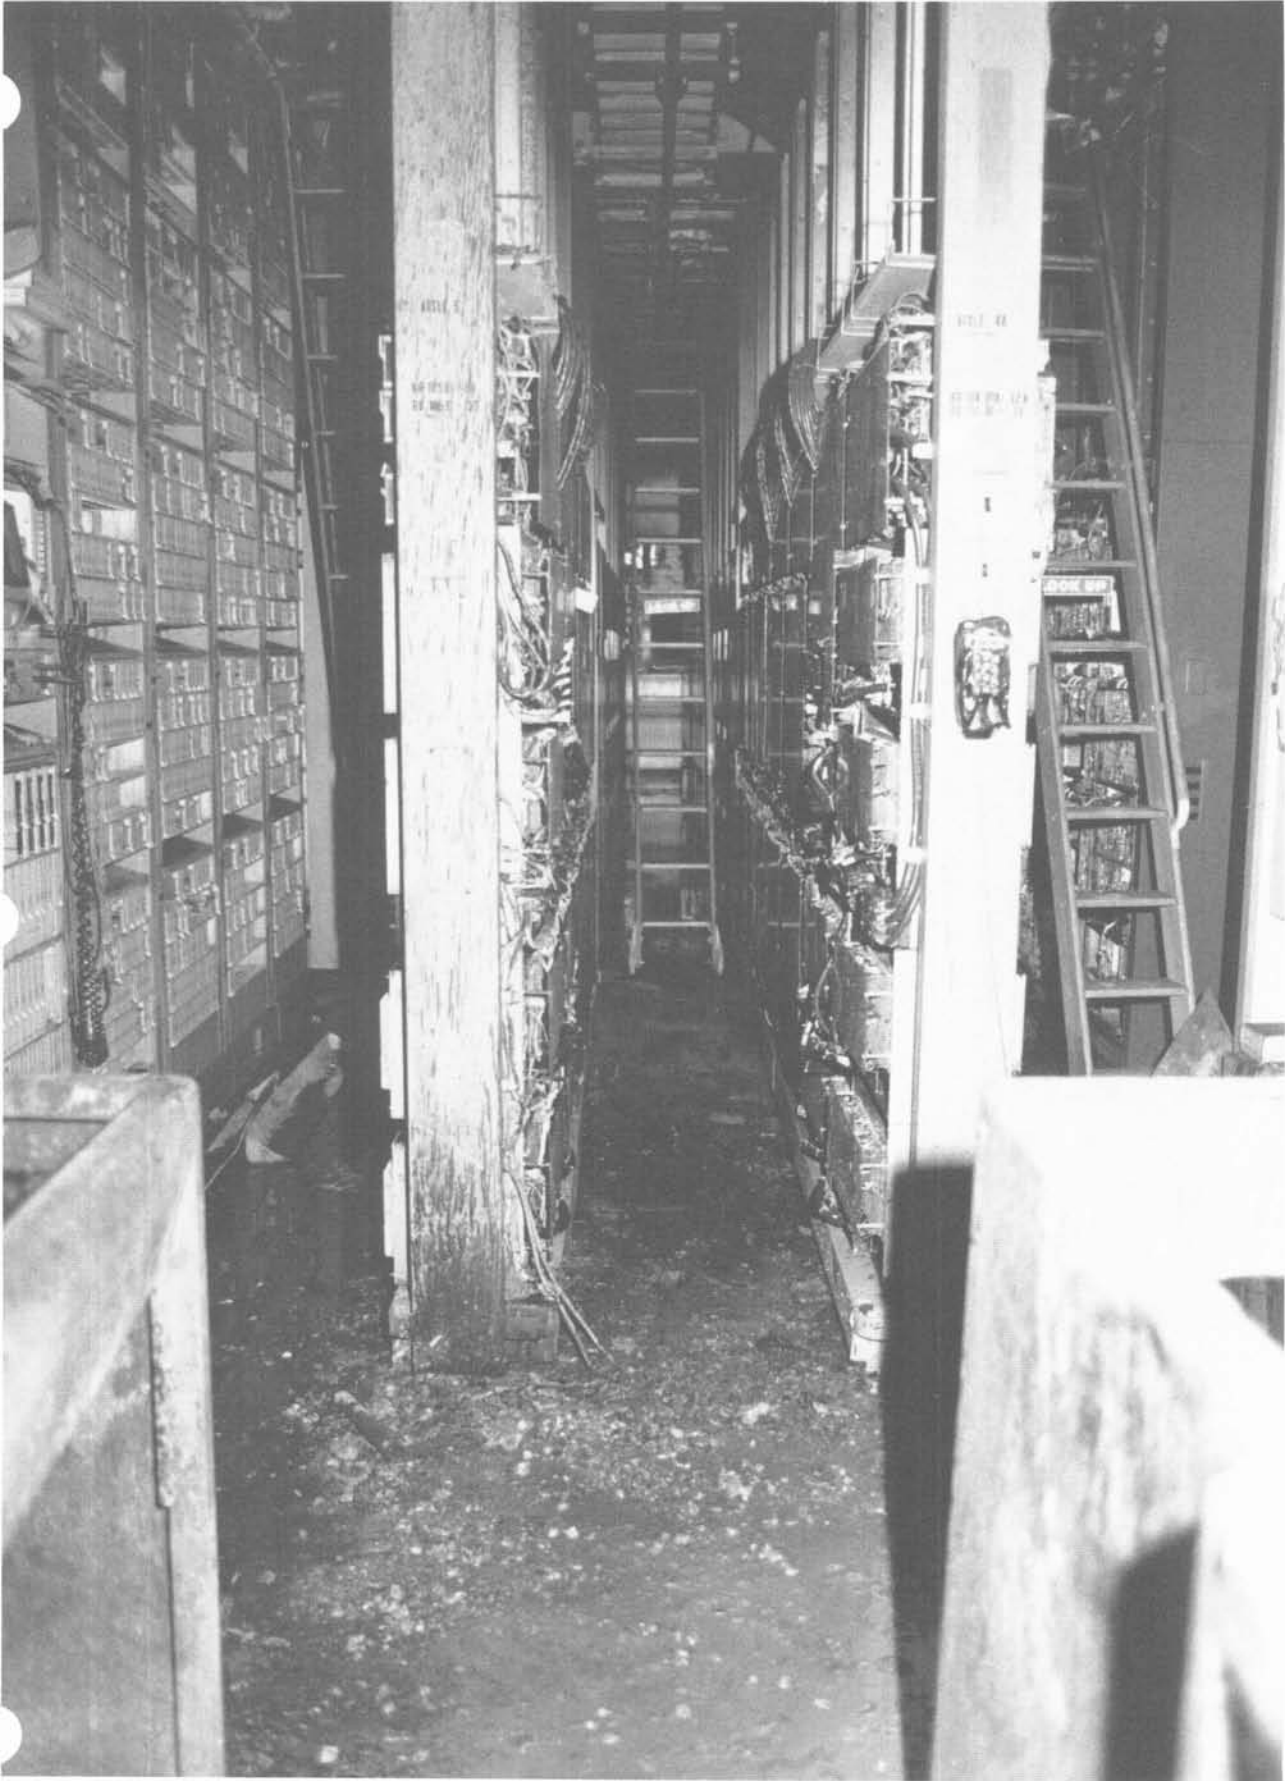
Photograph 3.
Fire damage below cable trays shown in Photograph 2.
