The Hinsdale Challenge

April 10 or 11, 1989

| HINSDALE: RETROSPECTIVE INVESTIGATION | MICHAEL J. FRIDUSS VICE PRESIDENT-OPERATIONS MICHIGAN BELL | TAB 4 |

**HINSDALE
RETROSPECTIVE INVESTIGATION**

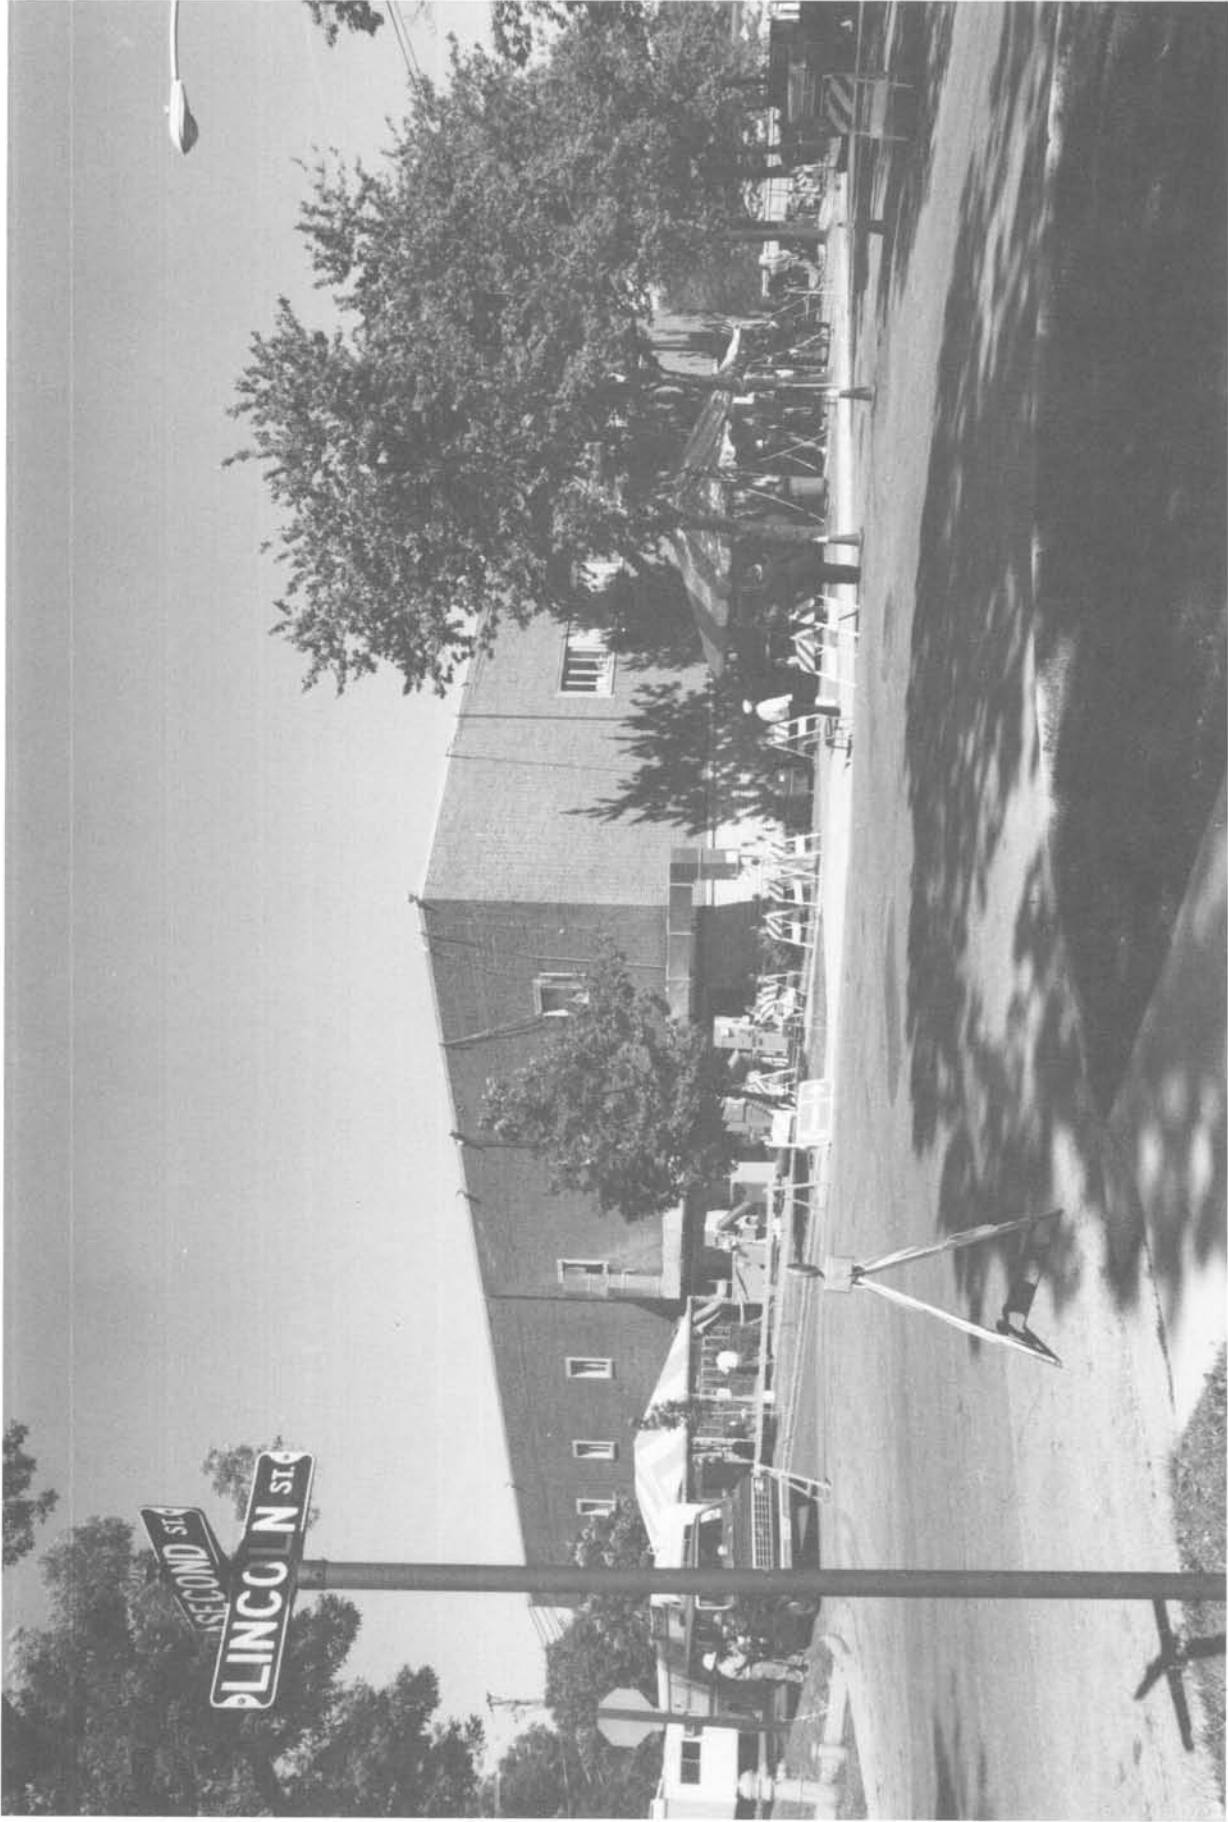
Photograph 2.1.
The Hinsdale Central Office Building during recovery.

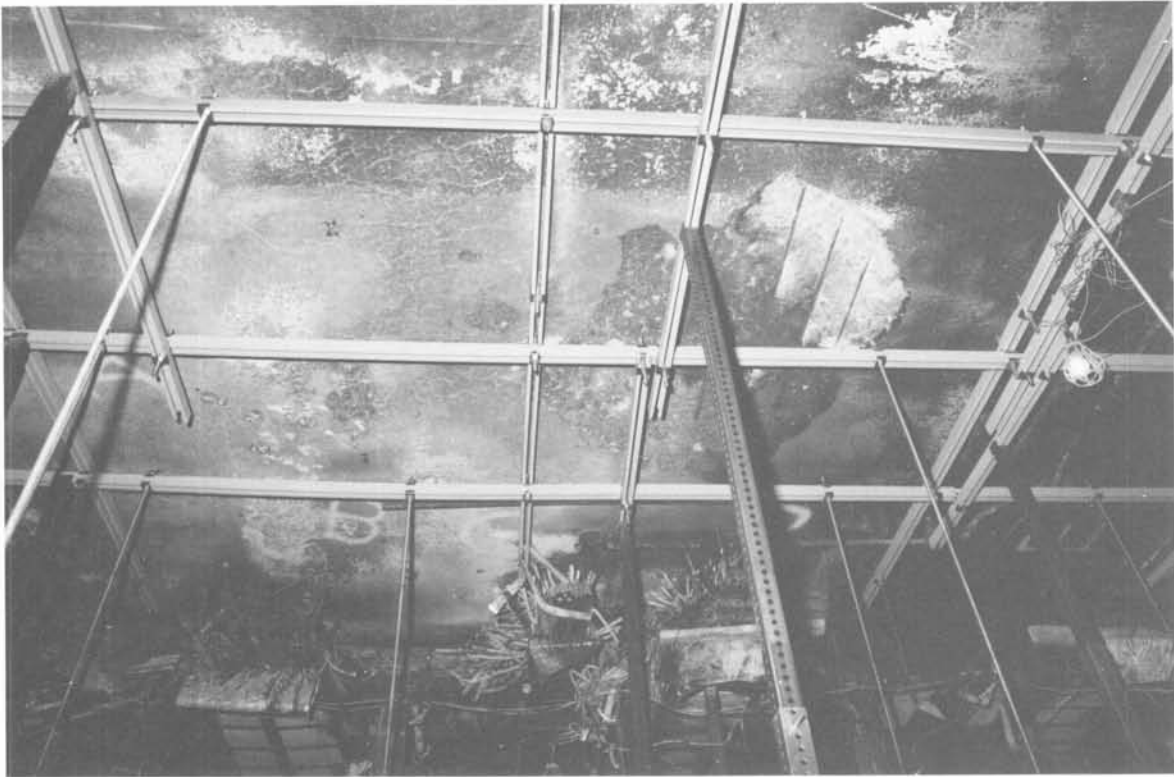
Photograph 3-4.
Part of ceiling area above Section 1.

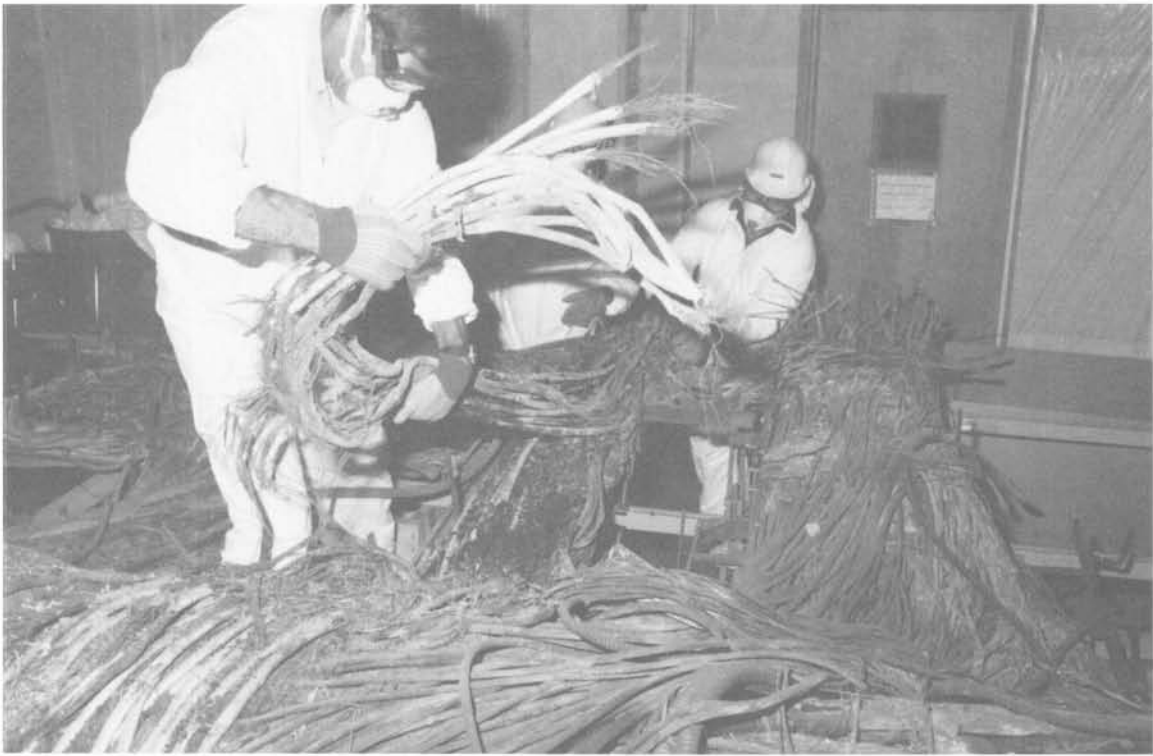
Photograph 3-11.
Removal of communications cables from Section 1.

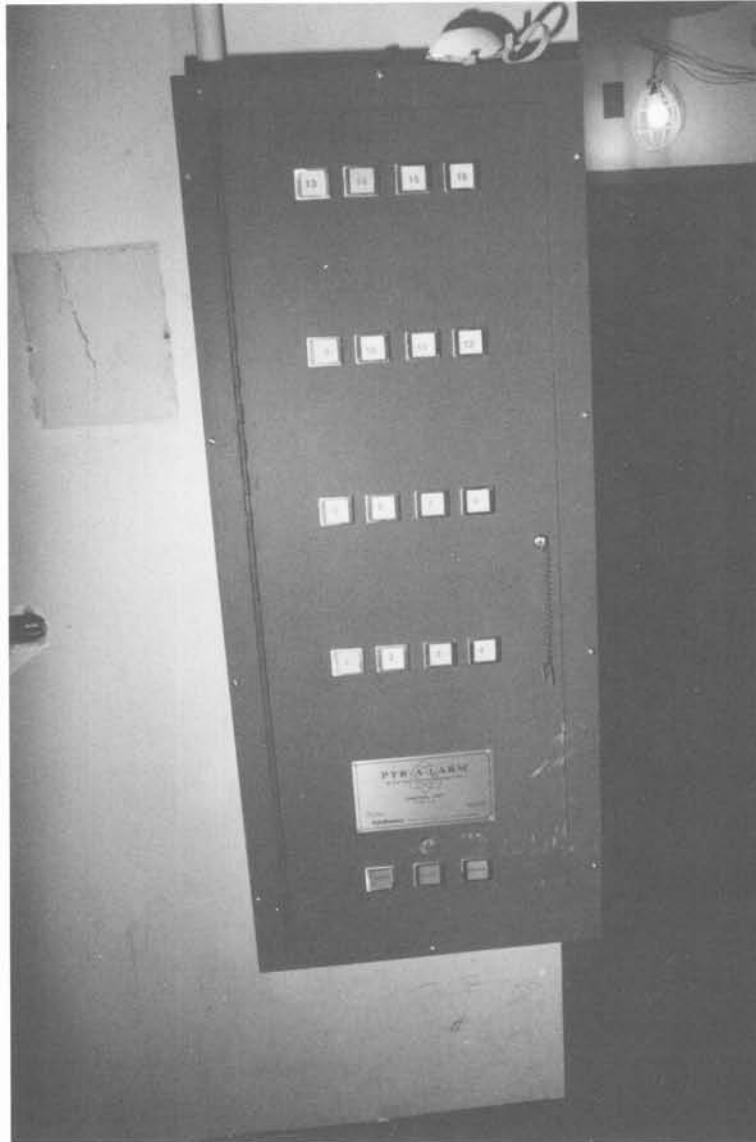
Photograph 3-26.
Pyrotronics fire alarm annunciator panel
on the first floor.

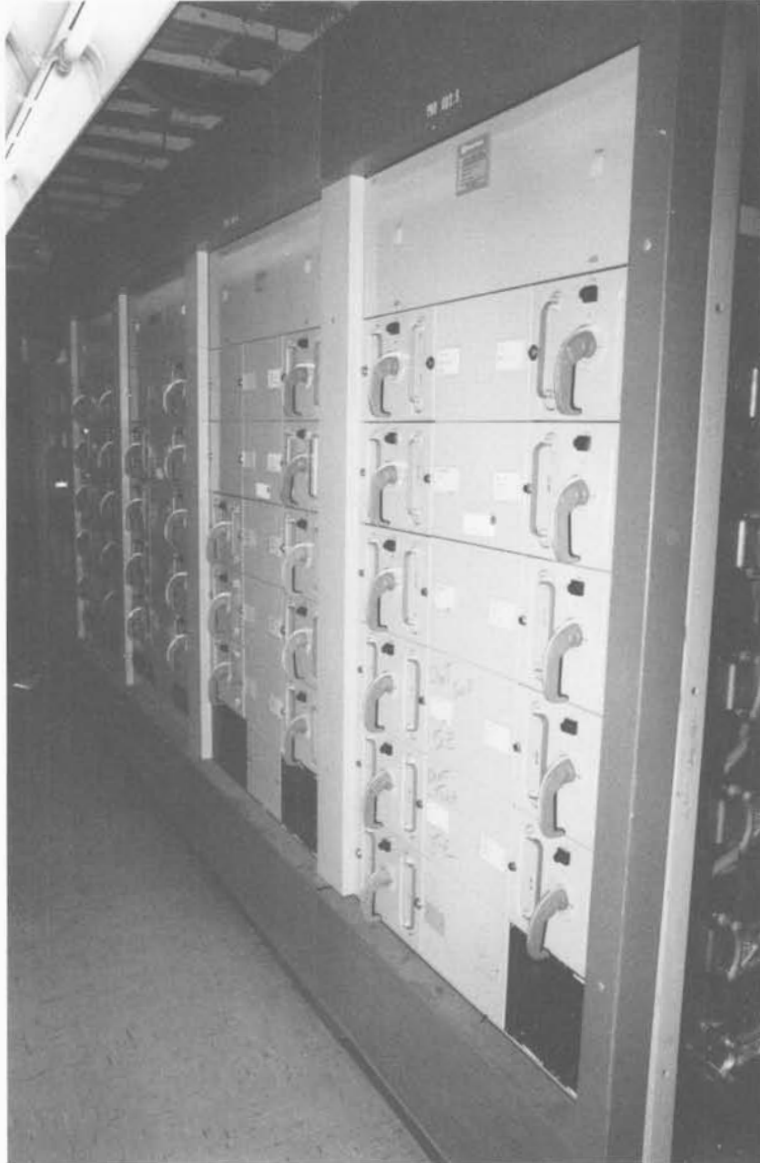
Photograph 3-33.
326 power supply fused discharge bay in basement.
