The Hinsdale Challenge

April 10 or 11, 1989

| HINSDALE: RETROSPECTIVE INVESTIGATION | MICHAEL J. FRIDUSS VICE PRESIDENT-OPERATIONS MICHIGAN BELL | TAB 4 |

**HINSDALE
RETROSPECTIVE INVESTIGATION**

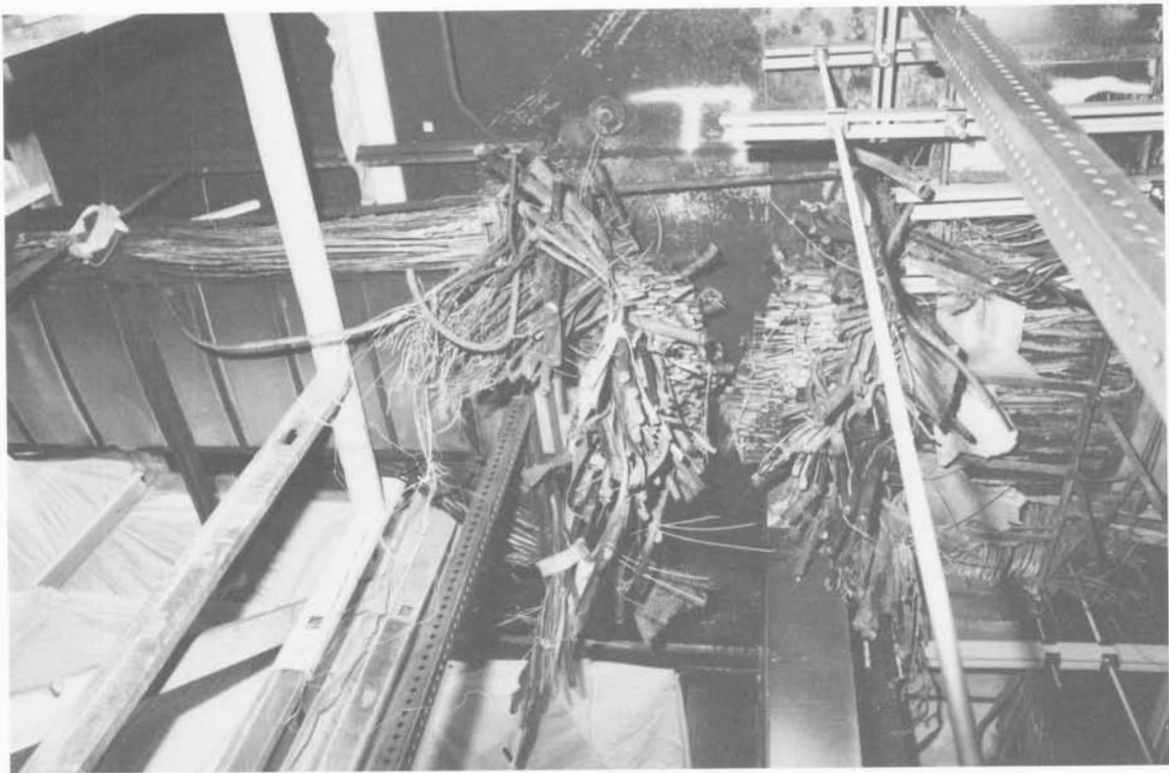
Photograph 3-2.
Section 1, F cut.
